Time Domain Reflectometer Analysis of Coaxial Feedlines for Various Repeaters in The Kansas City Room

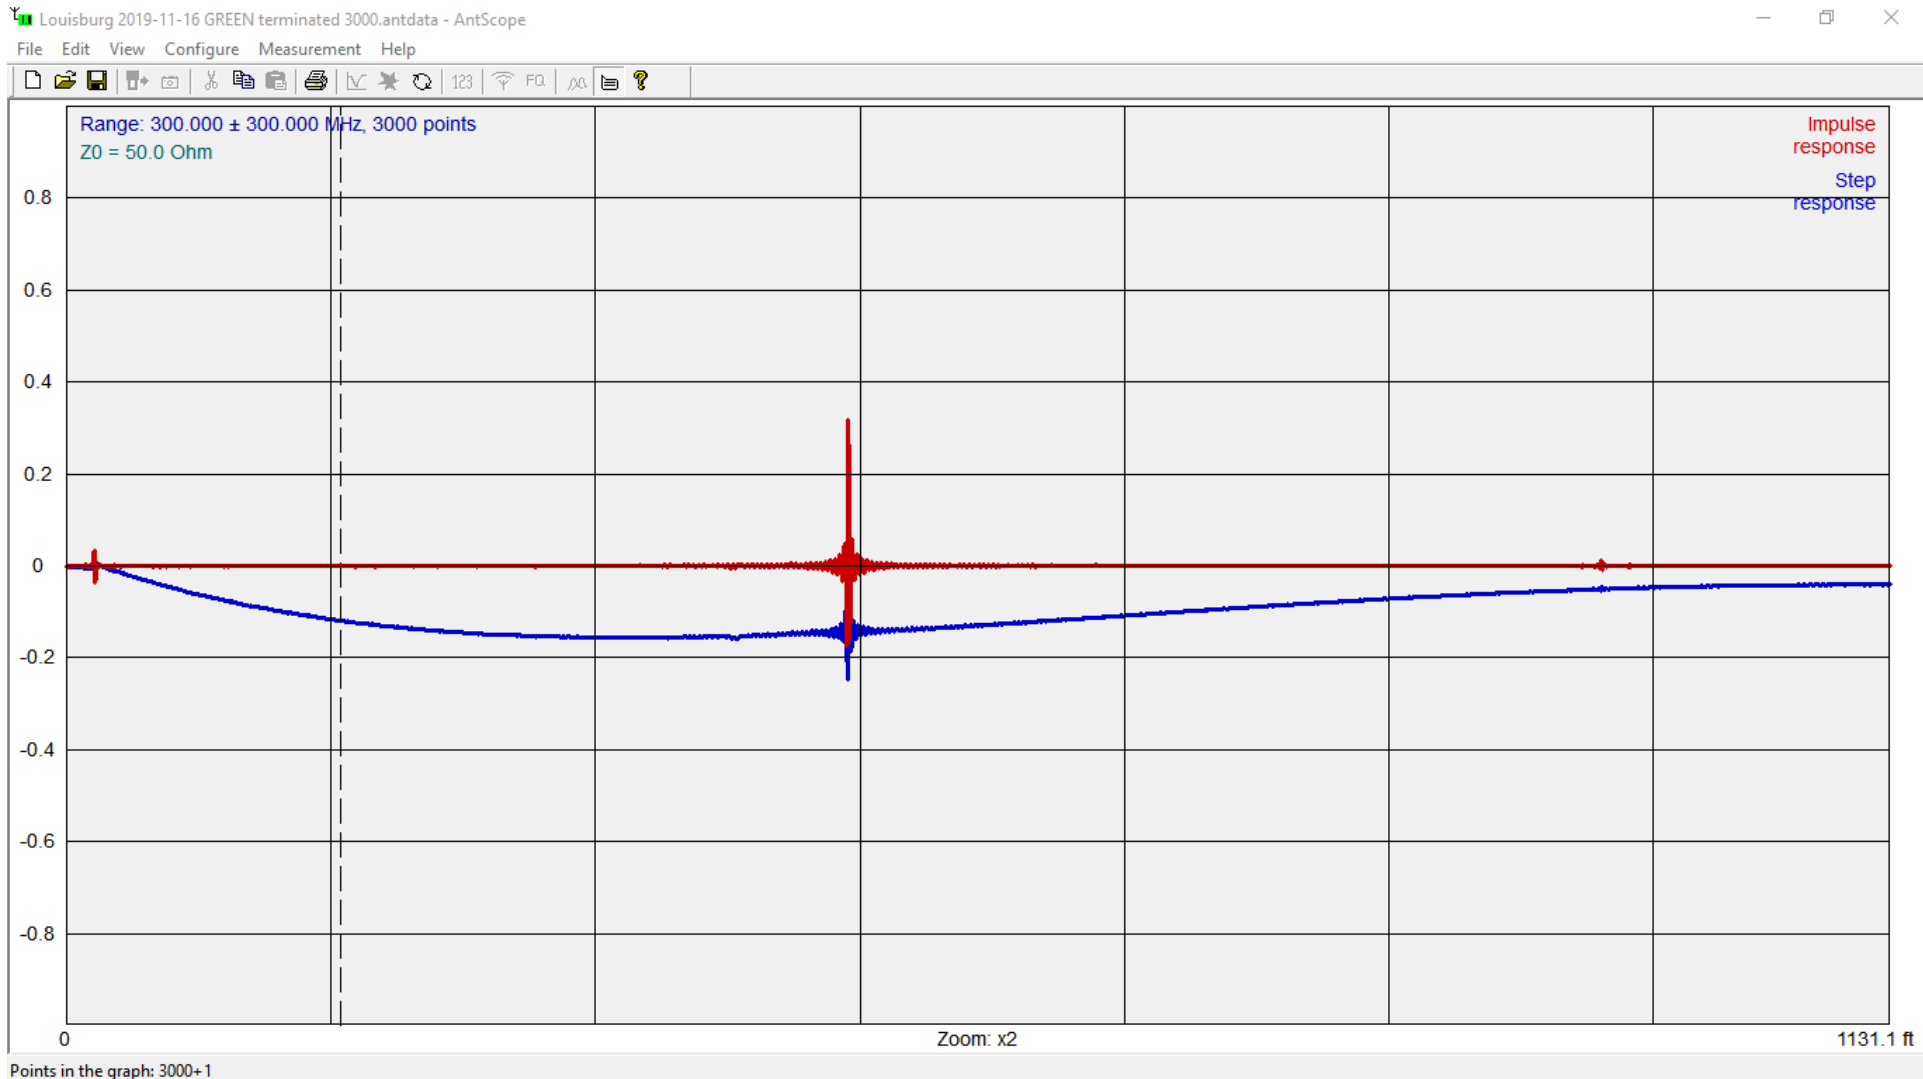
This is the scan of the bad feedline terminated into a 50 ohm load at the top of the tower. The red and blue lines are supposed to run parallel to each other. As you can see there is a problem with this feedline. We don't know what the problem is, just that it's not normal. Check out the SWR plot on the next page for this feedline.

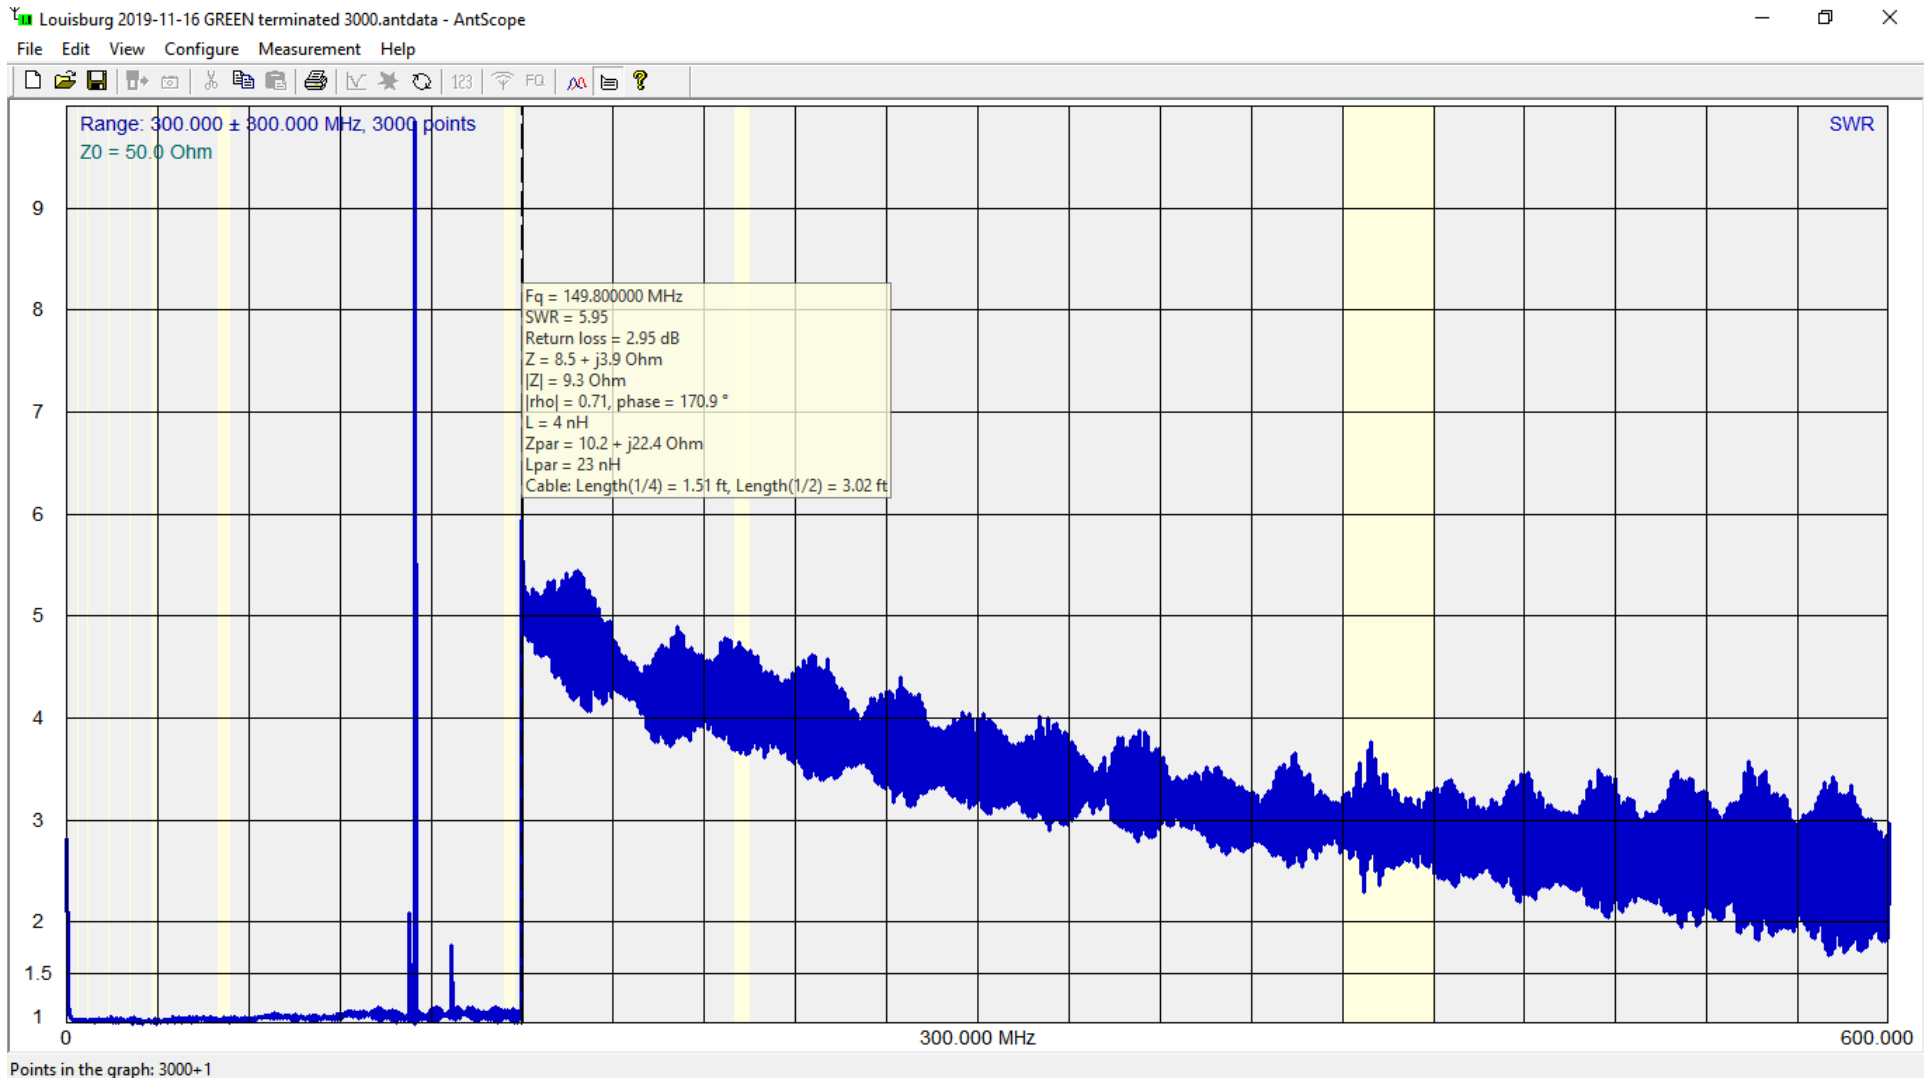
This is the SWR plot of the previous page. Since the antenna is terminated into a 50 ohm load the SWR should be flat over the entire frequency range. However notice how the SWR jumps from 1.12 to 5.95 at 149.800 Mhz. Definitely a problem with this feedline. If all you did was take an SWR reading at your VHF frequency you would think this feedline is fine. We think the thickness of the plot line is because of the high RF environment and RF coming back down the feedline.

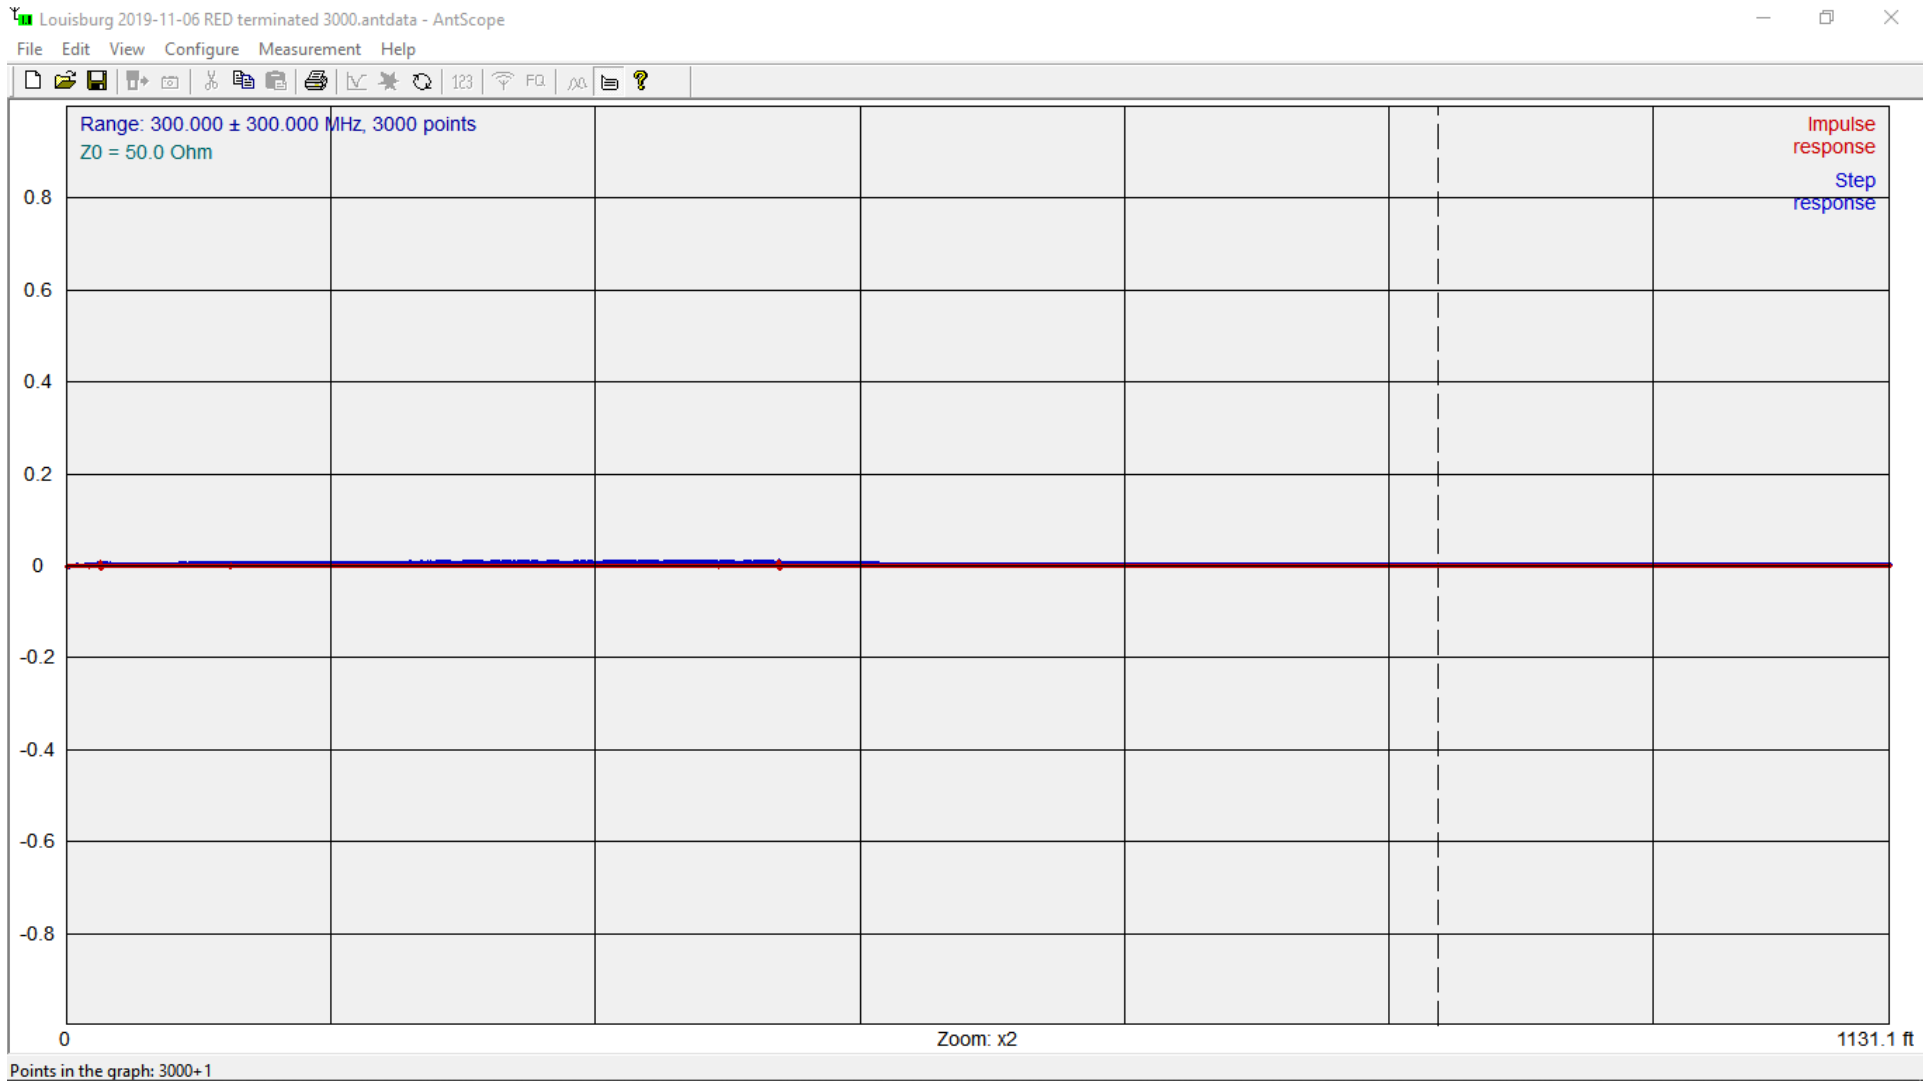
This is the scan of the good feedline terminated into a 50 ohm load at the top of the tower. As you can see the red and blue lines are parallel to each other. This indicates that the feedline is good with virtually no loss in the line.

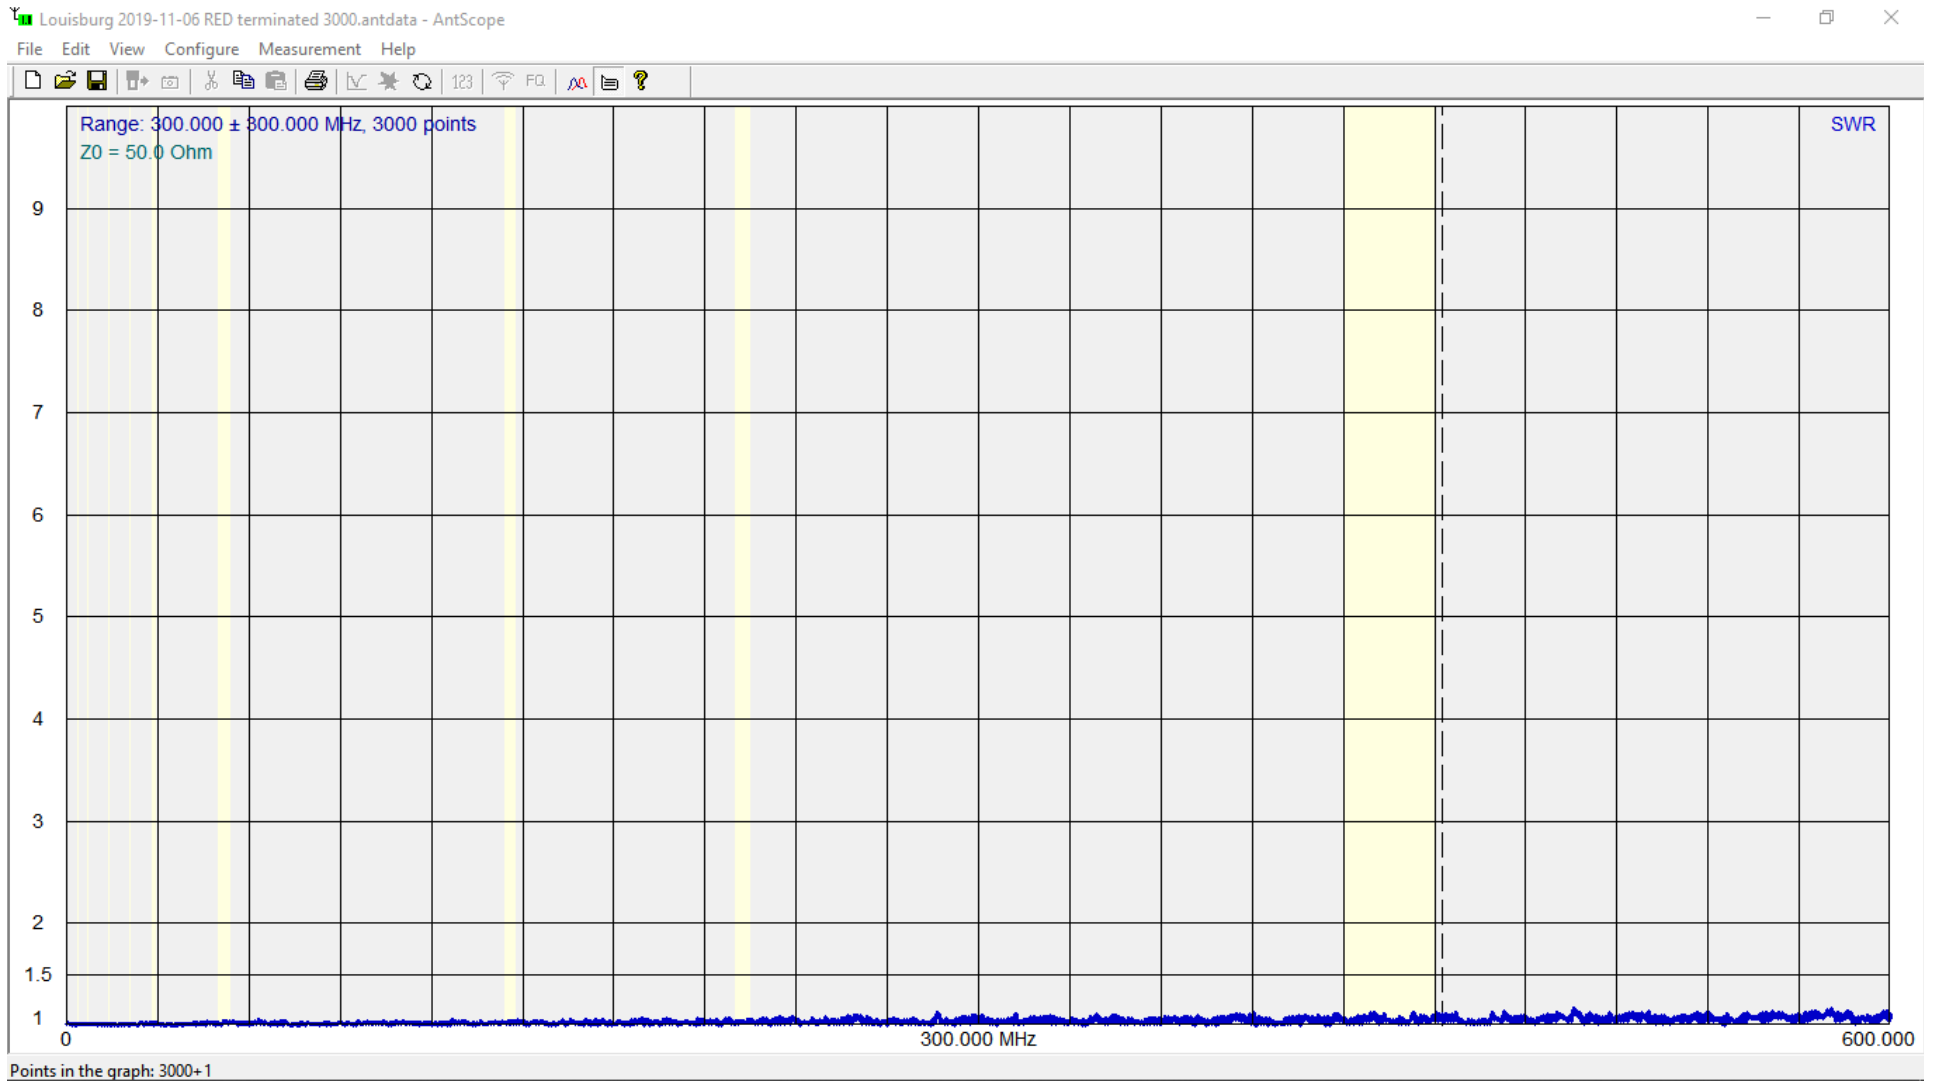
This is the SWR plot of the previous page. The feedline is terminated into a 50 ohm load and the SWR is flat almost across the entire frequency spectrum, going up slightly as it reaches the upper frequencies. This is definitely a good feedline.

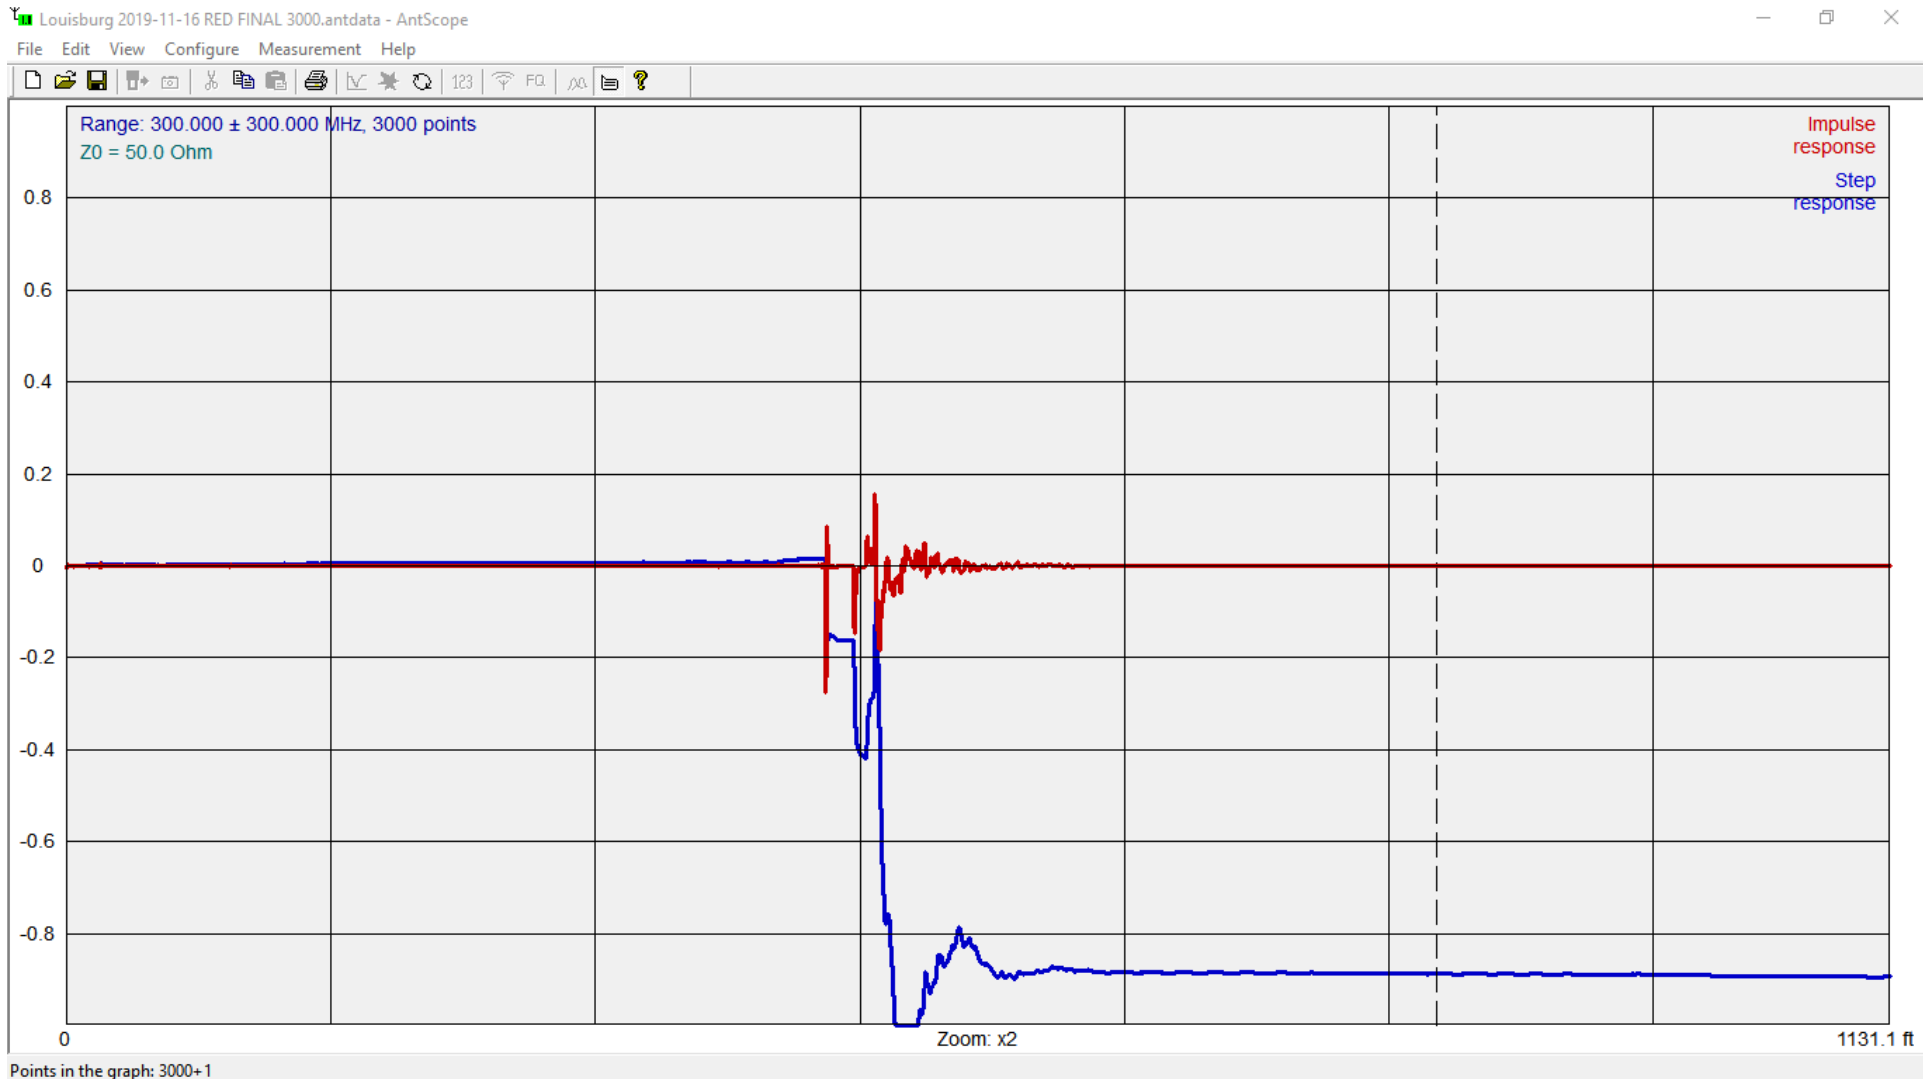
This is the good feedline connected to the good antenna. The red squiggles are the reflection from the antenna itself and do not indicate a problem. The blue line indicates a grounded antenna.

To make a really long story short, through our TDR analysis we found that we had one good feedline and one bad feedline. We also discovered we had one good antenna and one bad antenna. As luck would have it the good antenna was on the bad feedline. So we moved the good antenna to the good feedline and that improved our reception immensely.

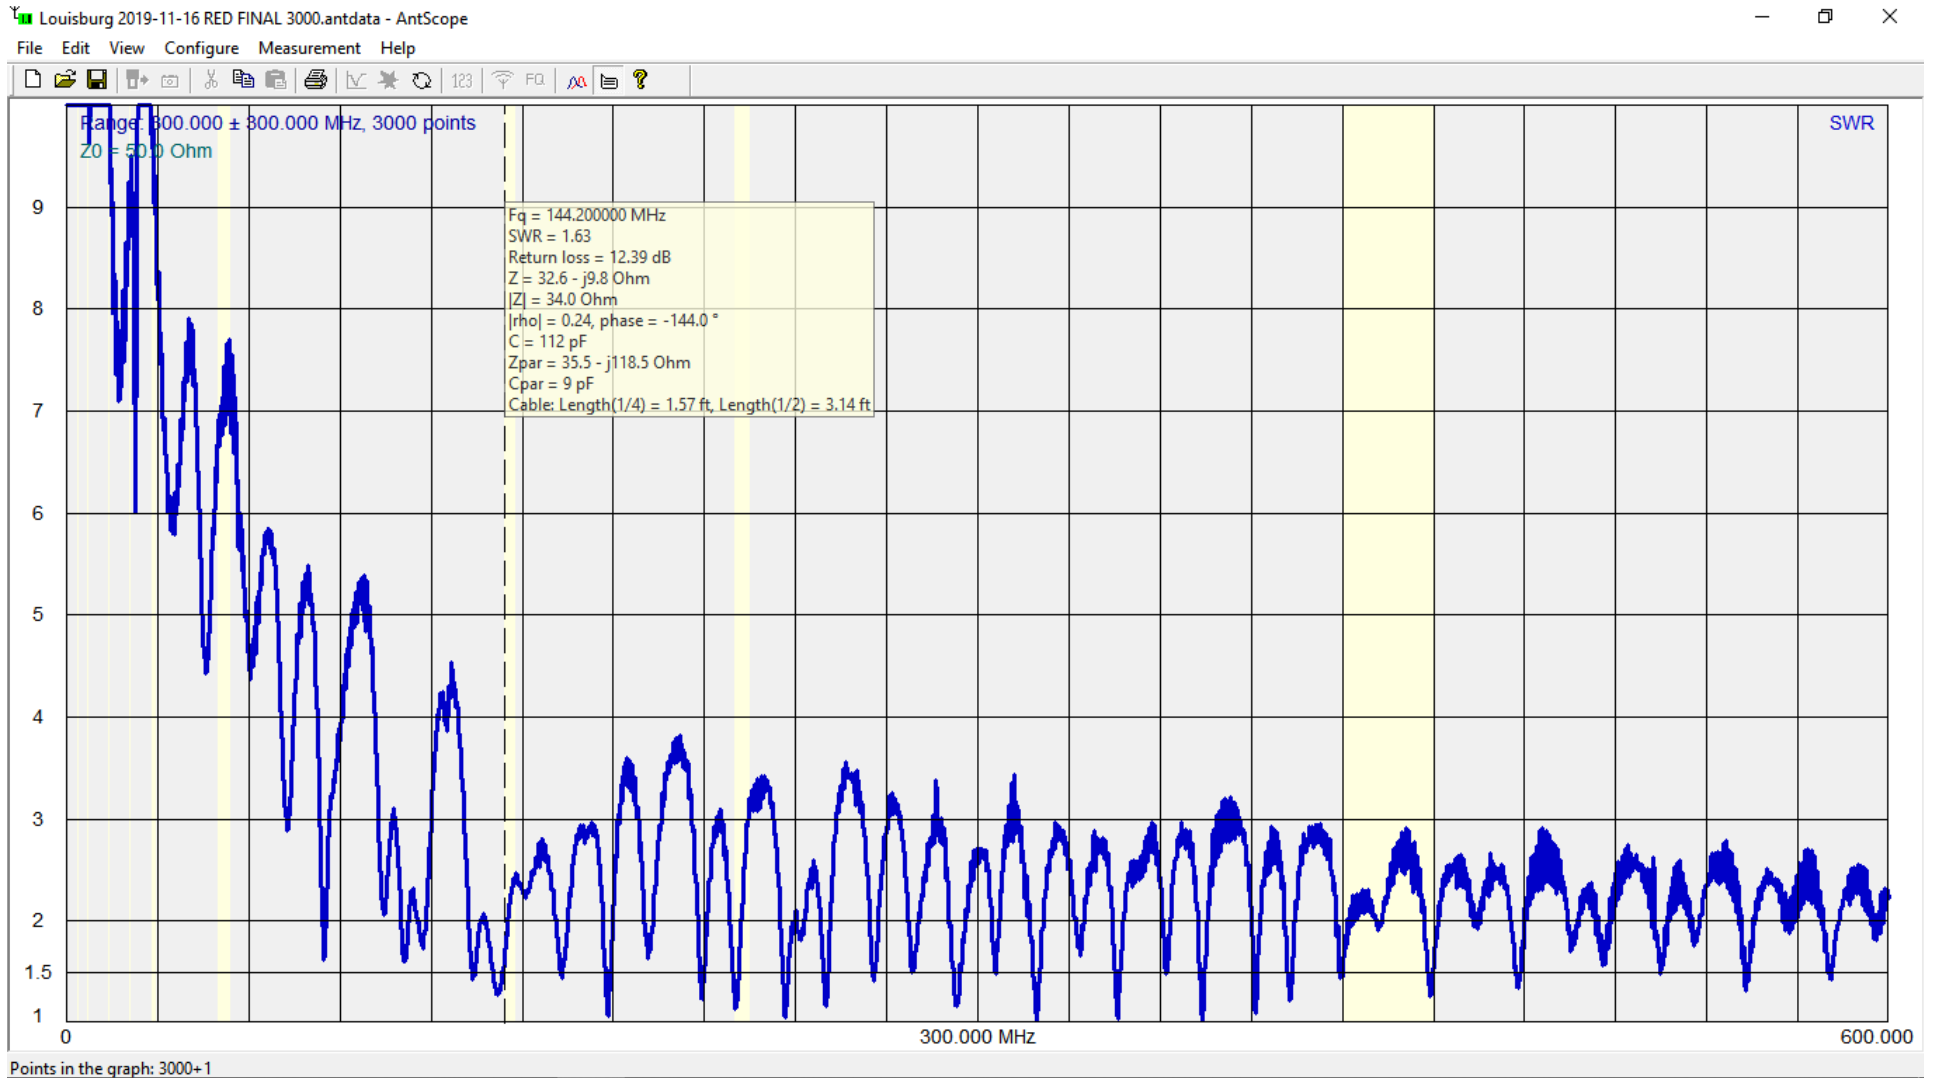
This is the SWR plot of the previous page. The feedline is now connected to the antenna. Notice the SWR at 144.200 Mhz is 1.63:1. Our repeater frequency is 145.410 Mhz. We can have confidence that the antenna and the feedline are performing adequately.

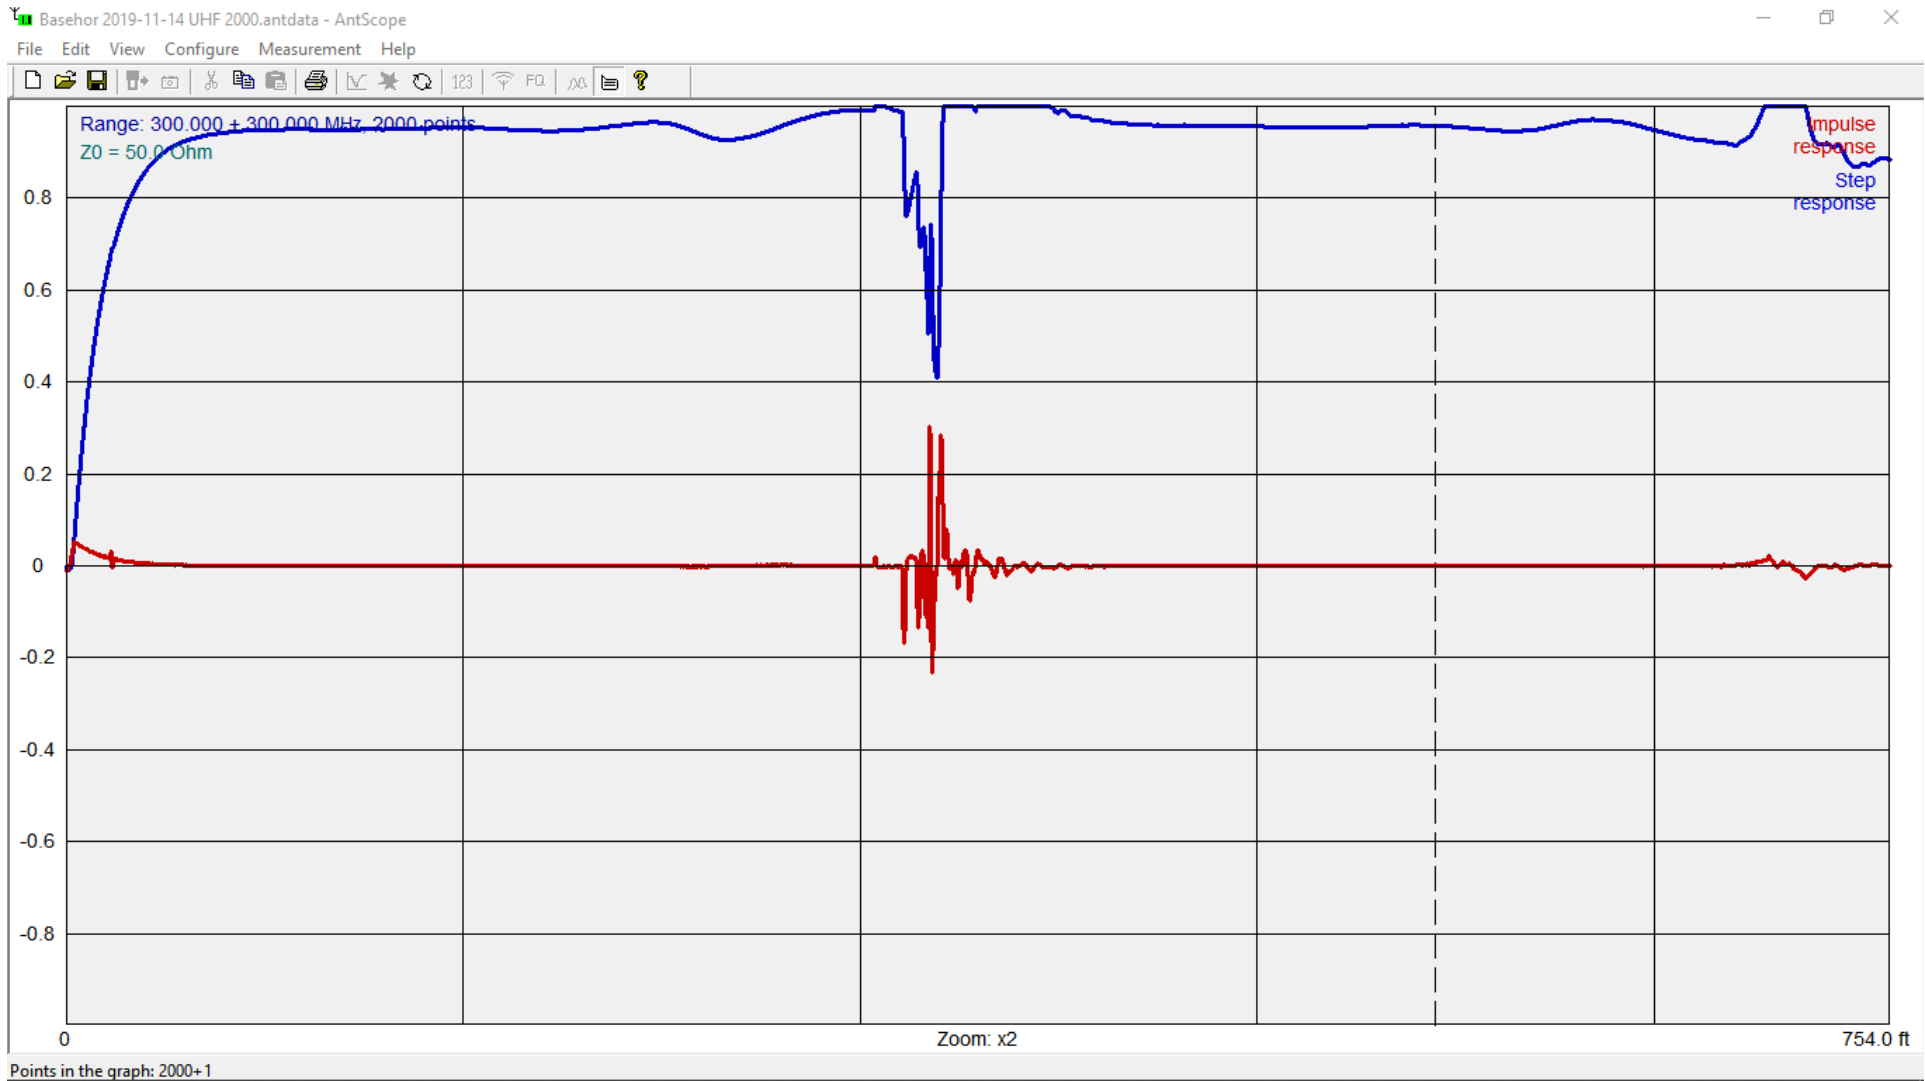
This is a scan of a feedline at another of our repeater sites. This one threw us for a loop initially because we were confident that the feedline was good. It turns out that this step response is because there is a lightning arrestor in the feedline where it enters the building. We removed the arrestor and did another scan and it is shown on the next page.

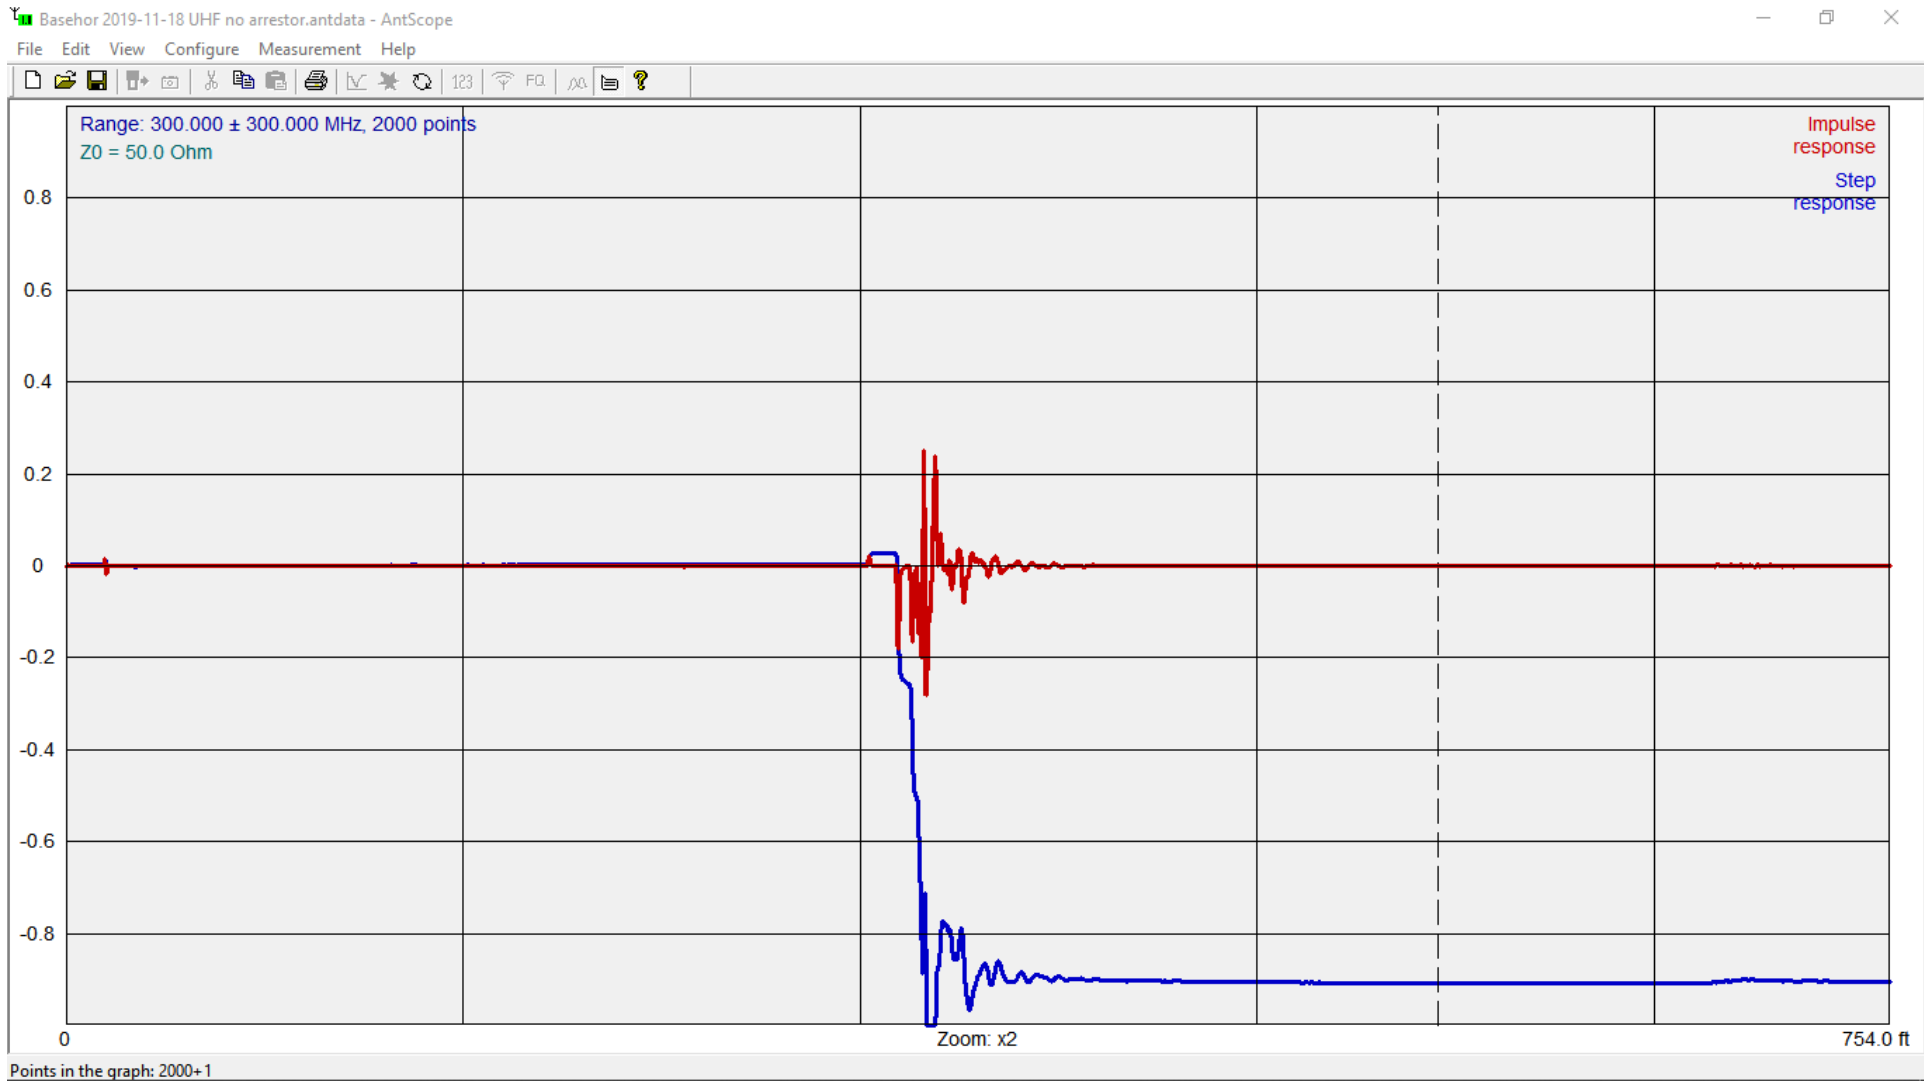
This is the same feedline with the lightning arrester removed. The little red squiggle at the far left is indicative of a connector in the line. The red squiggles in the middle are returns from the antenna and the blue line going down is indicative of a grounded antenna.

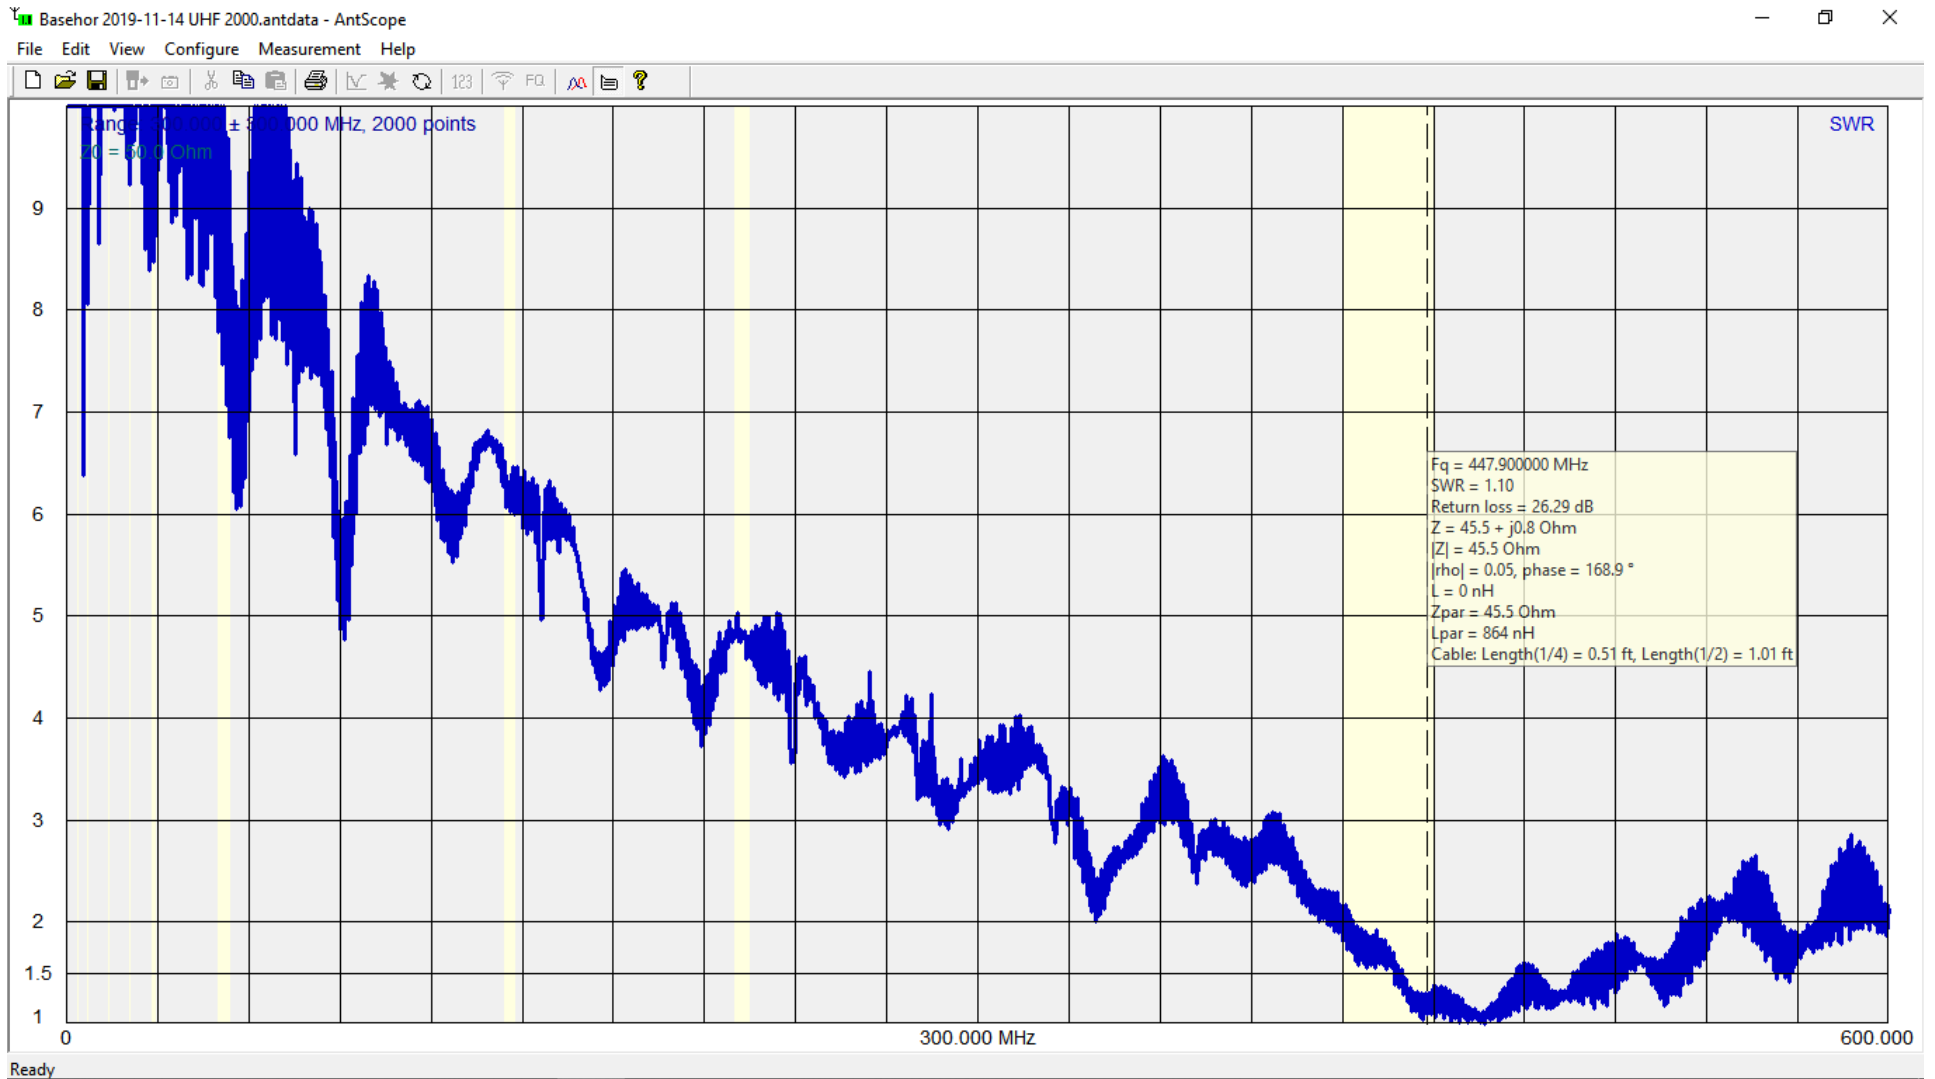
This is the SWR plot of the previous screen. You can see that the SWR in the UHF band is more than acceptable for a UHF repeater. Again we believe the thickness of the plot line is due to RF coming back down the feedline. There is a low power TV station co-located on the same tower.

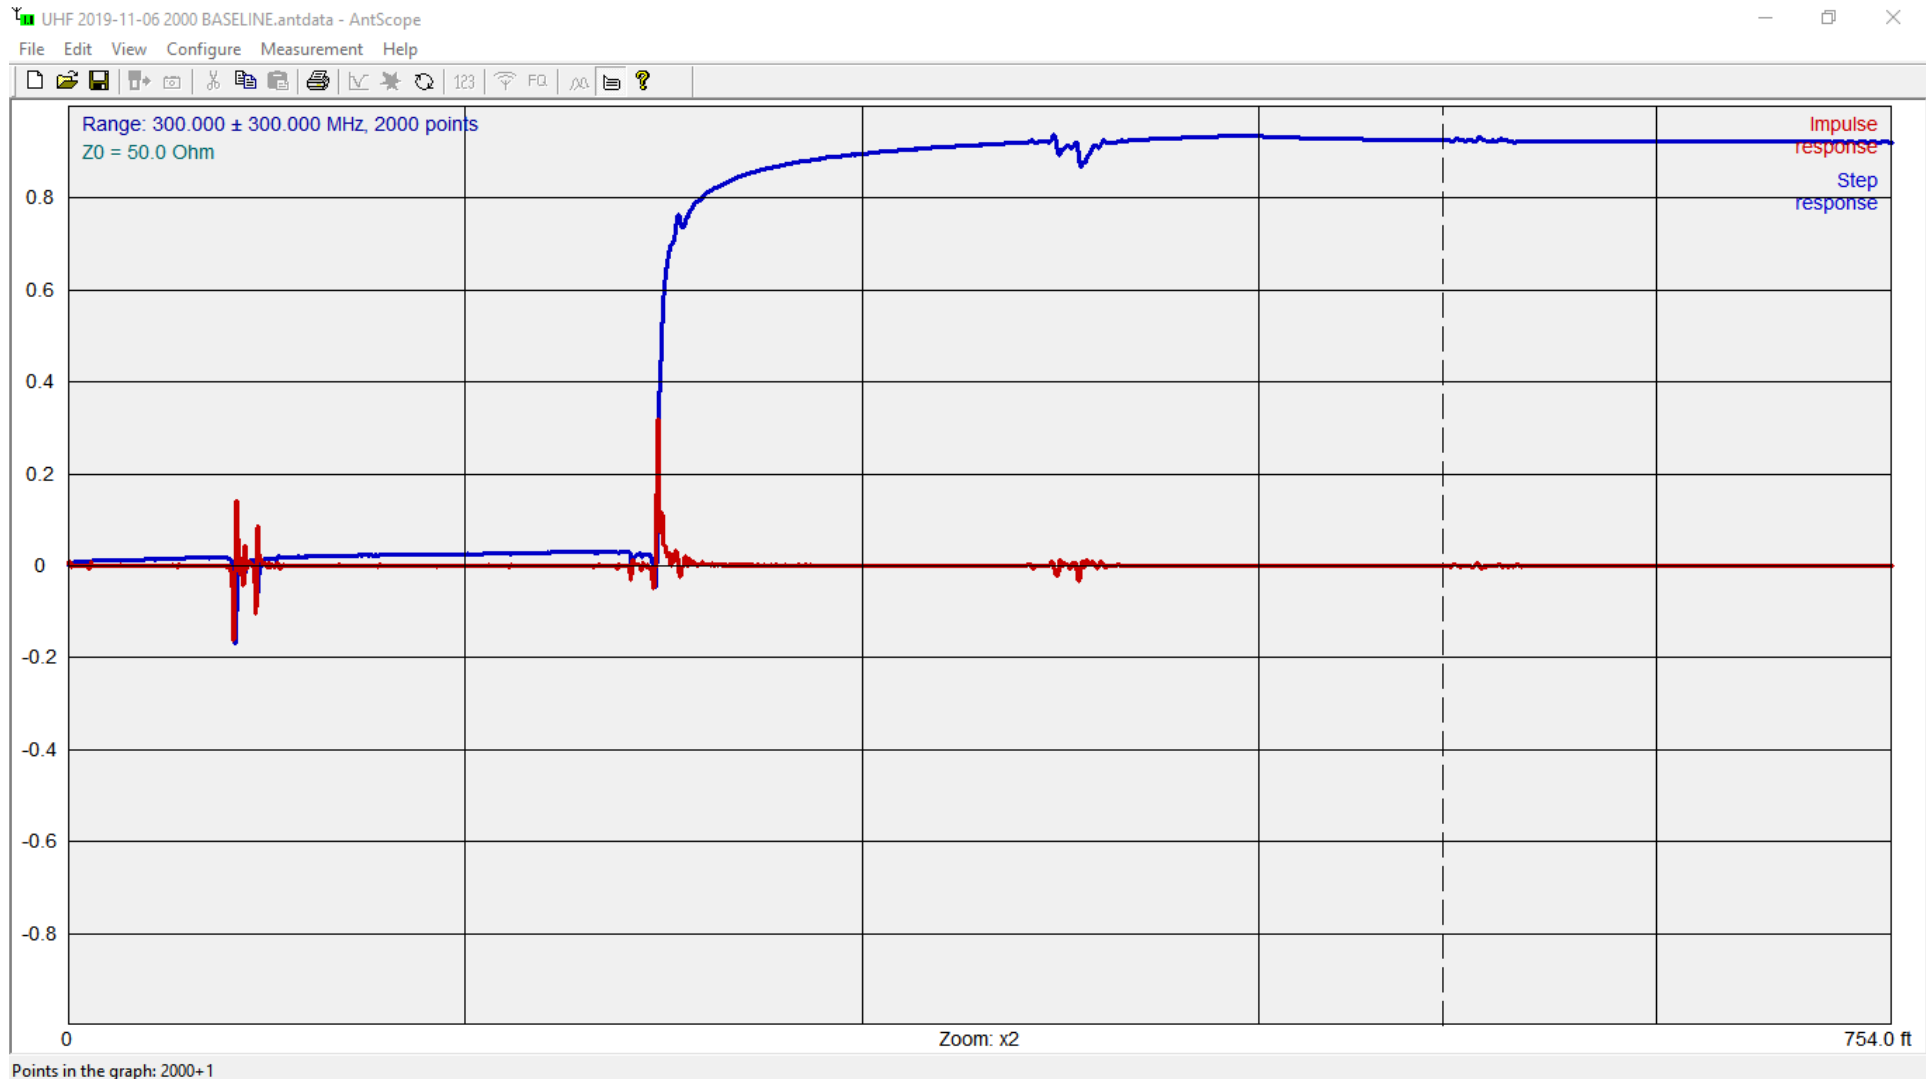
This feedline looks good from a loss perspective however there is something major wrong about a third of the way up the line. Without visual inspection we don't know what the problem is.
