Time Domain Reflectometer Analysis of Coaxial Feedlines for Various Repeaters in The Kansas City Room

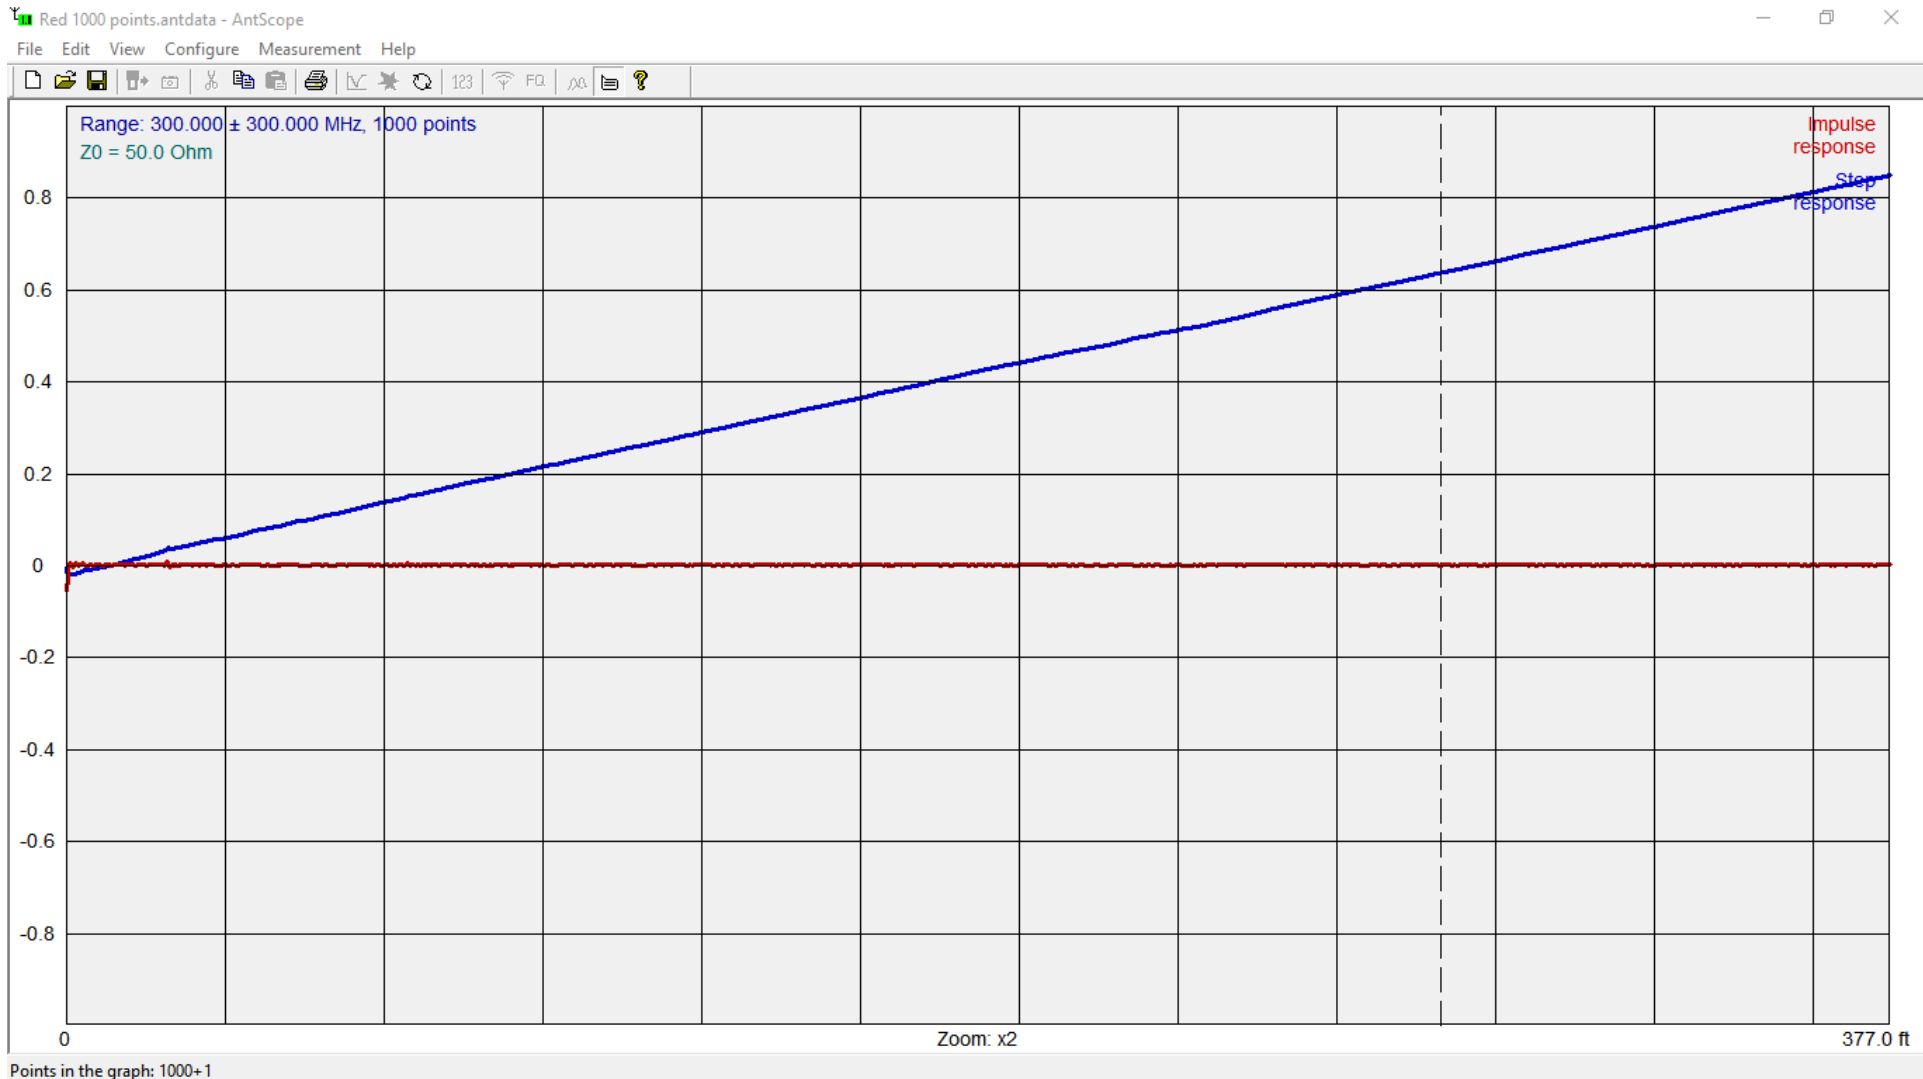
This is an example of not using enough points in the scan. The entire feedline is not represented in the graph. Increasing the number of points from 1000 to 2000 results in the graph on the next page. Notice the distance indicated on the graph is 377 feet. We know that the feedline is longer than 400 feet.

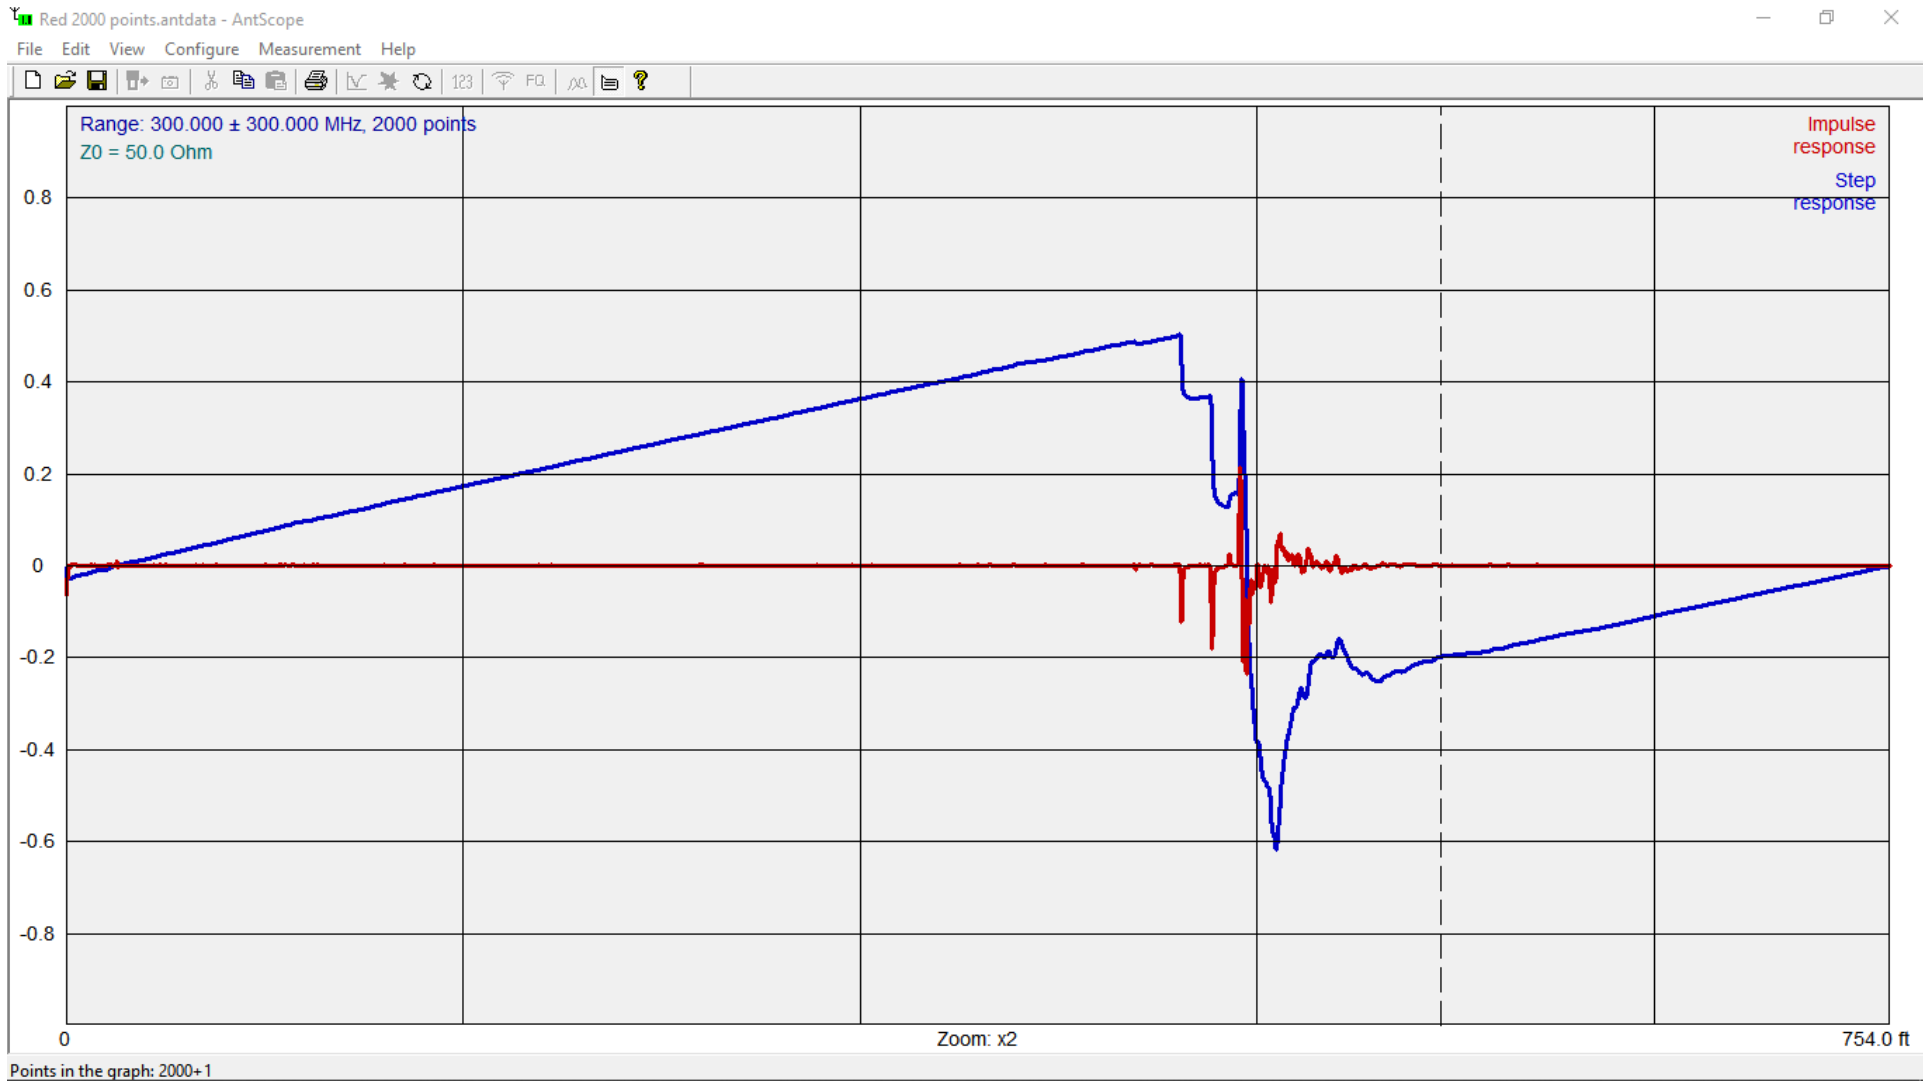
Increasing the number of points from 1000 to 2000 now displays the entire length of the feedline. This indicates an extremely lossy feedline and one that you wouldn't want to use. The higher the blue line goes the more the loss increases.

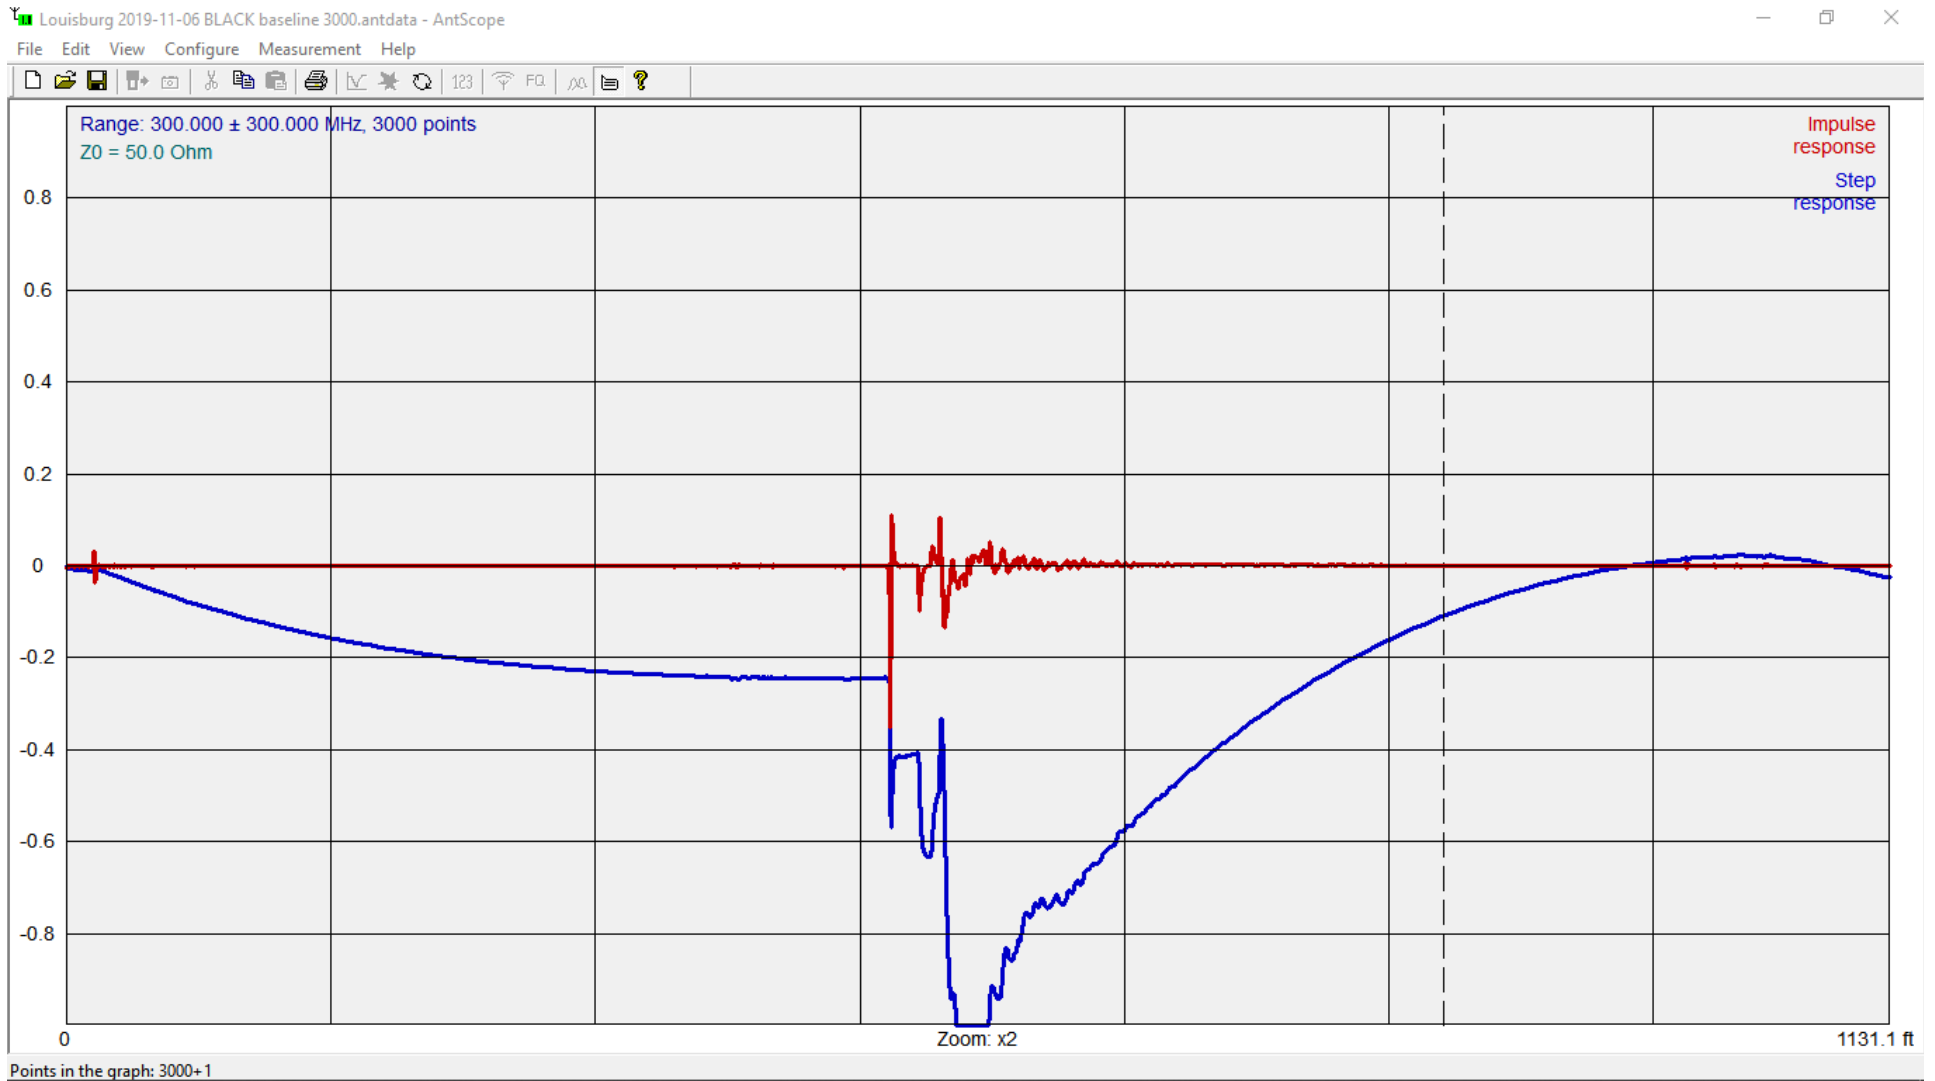
This is another scan that shows a feedline with problems. We didn't know what the problem was but after the termination was examined at the top of the tower it was determined that the coax connector had pulled partially apart at the antenna. After the feedline was disconnected from the antenna we ran another scan. It is on the next page.

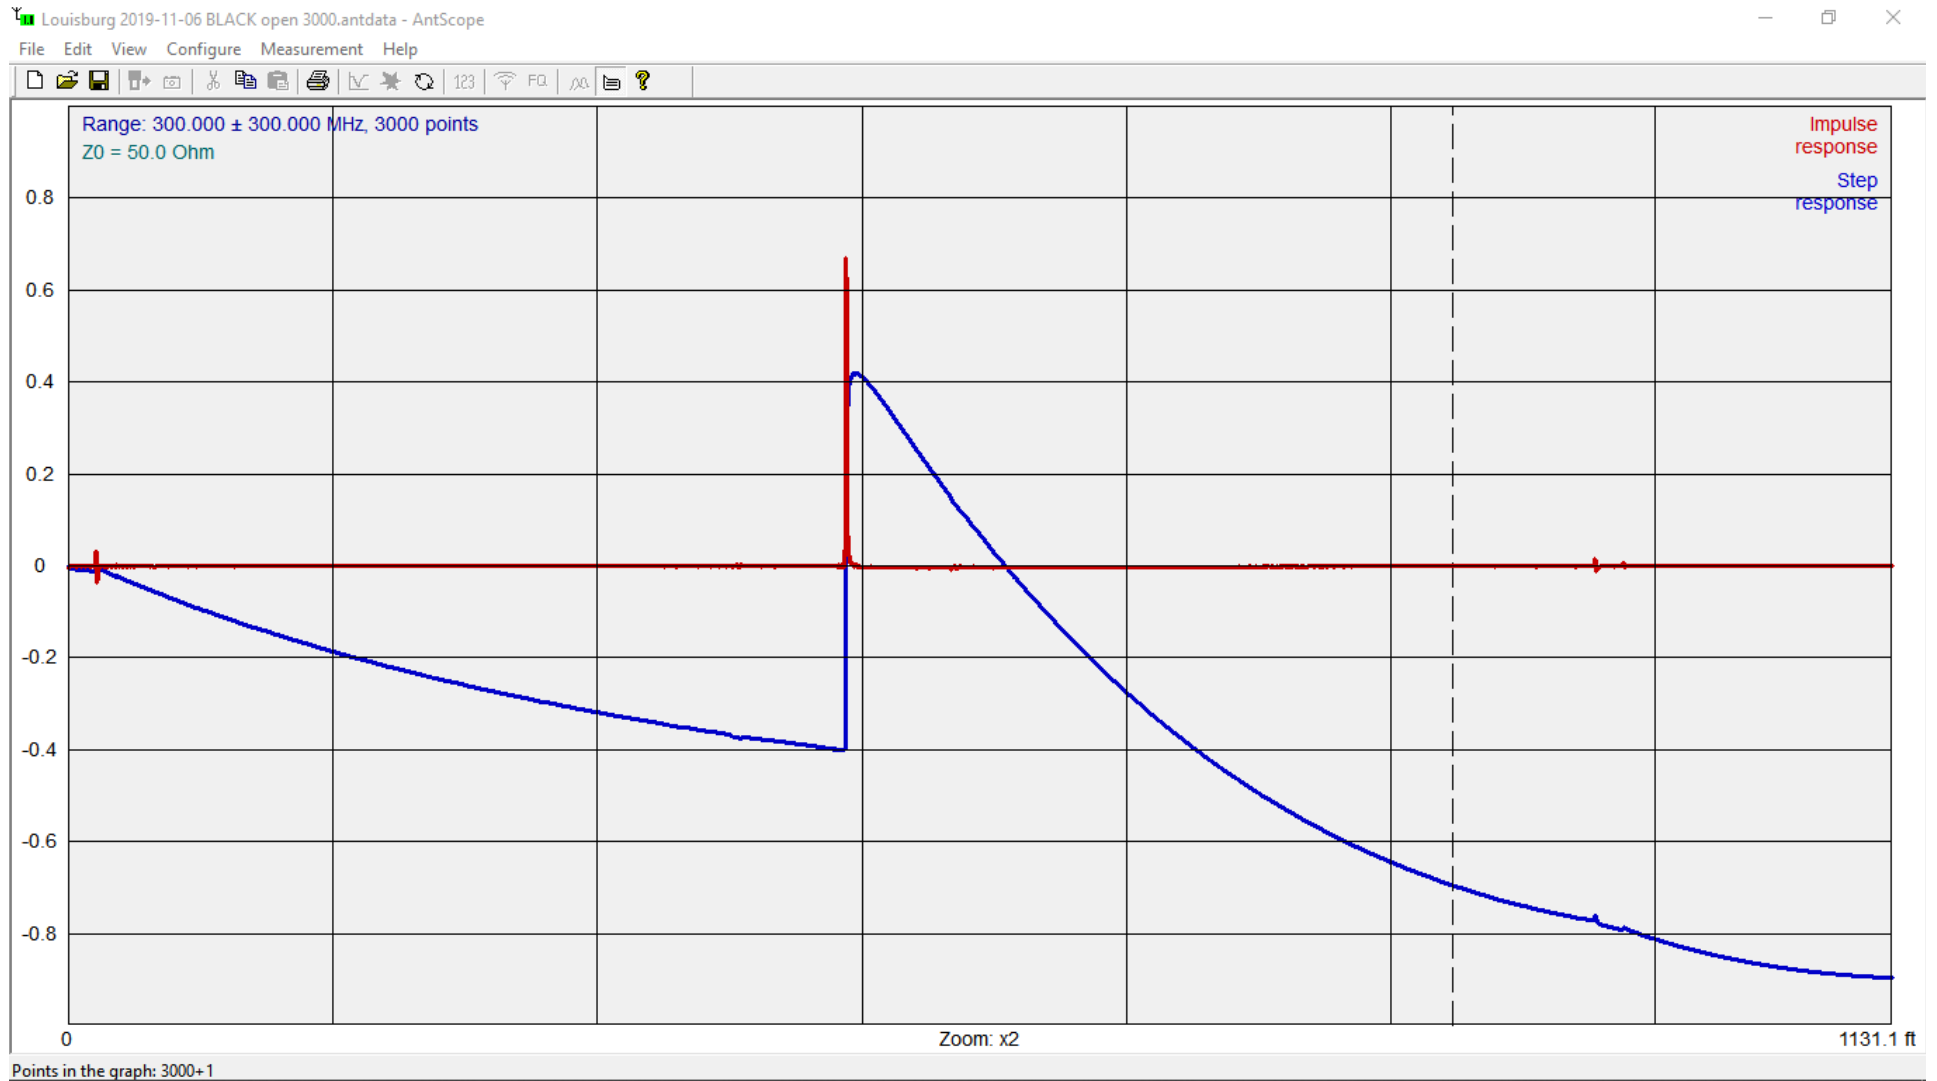
This is the same feedline shown on the previous page but the antenna has been disconnected and the feedline is open. It still shows a major problem with the feedline. Our determination was that this feedline was bad and unusable and we have no idea what is wrong with it.

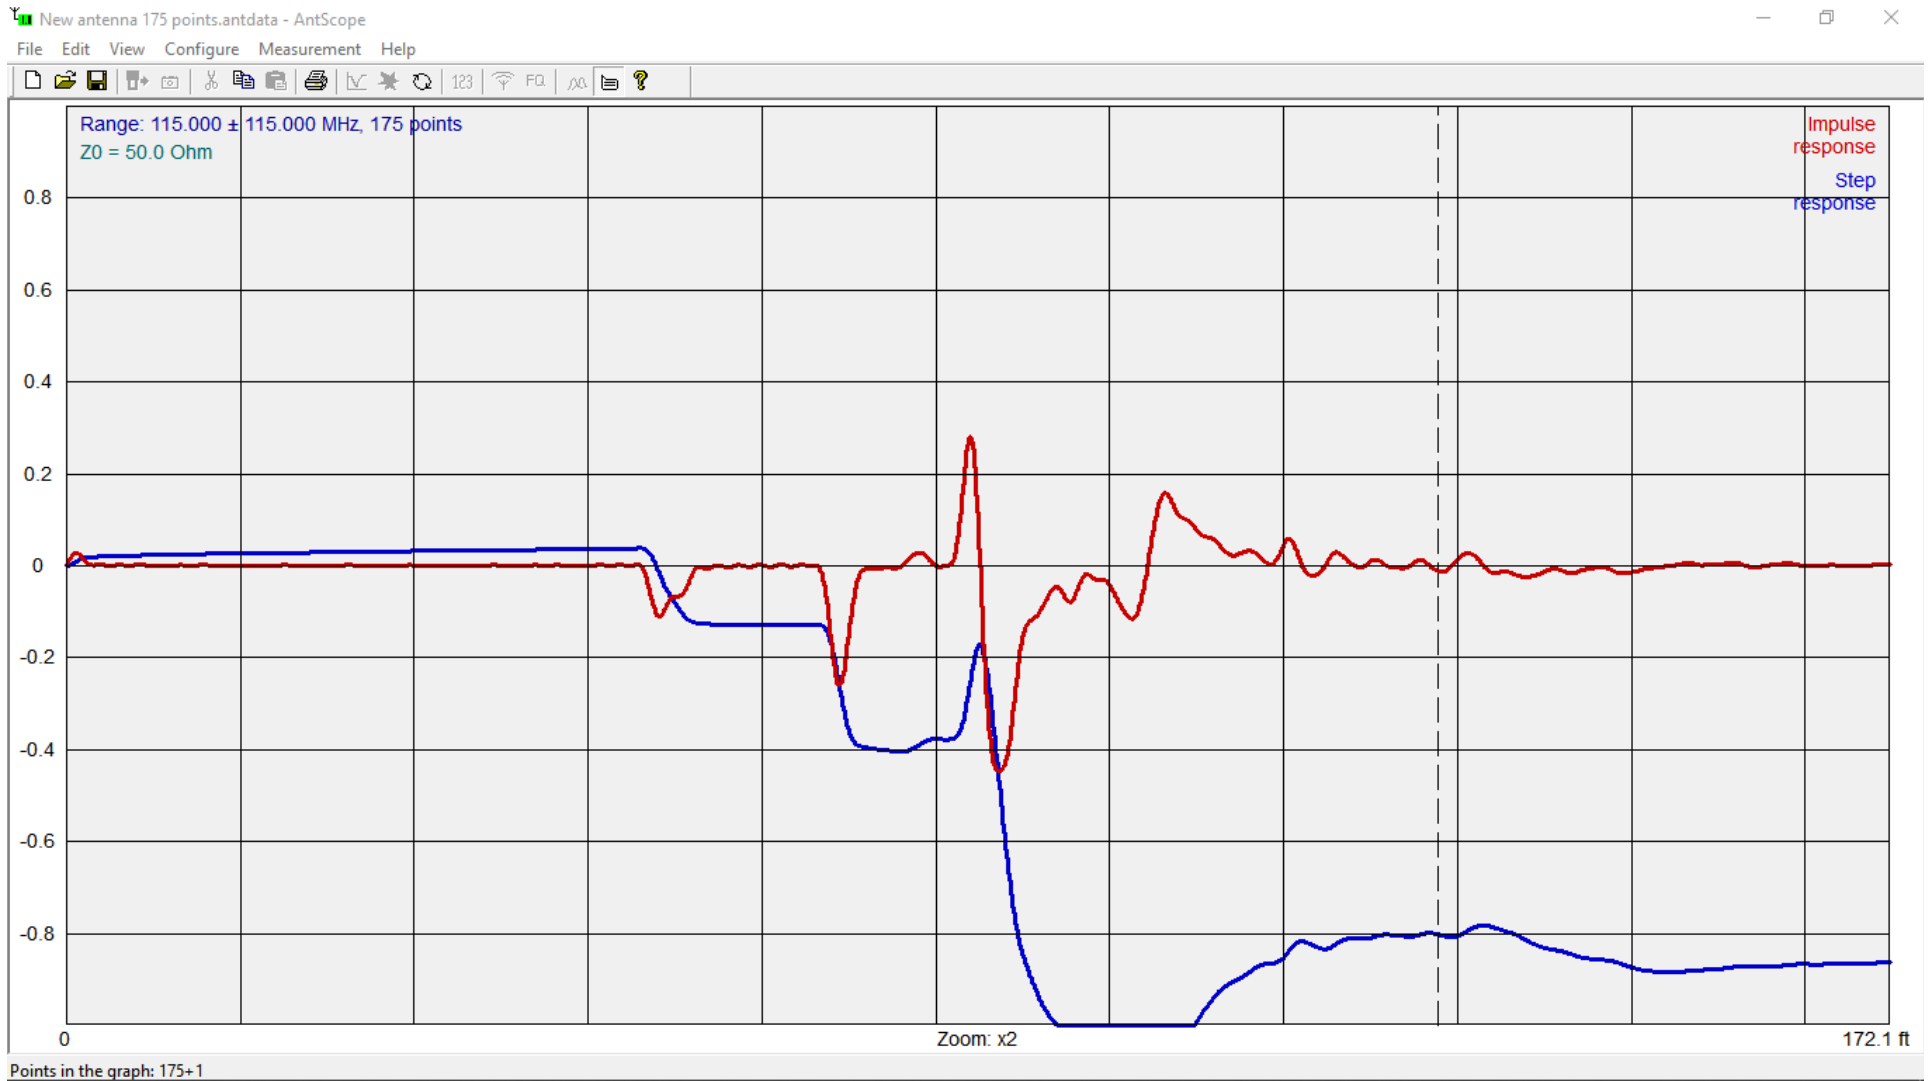
We tested a VHF 4 pole antenna by mounting in on a wooden fence post out in the open and connecting it to the AA-600 with 50 feet of coax. You can see that the coax becomes lossy as it approaches the antenna connection. The four red peaks and valleys may represent the 4 poles of the antenna. The red squiggles to the right are what is called ghost reflections. This scan was done with the AA-230 Zoom.

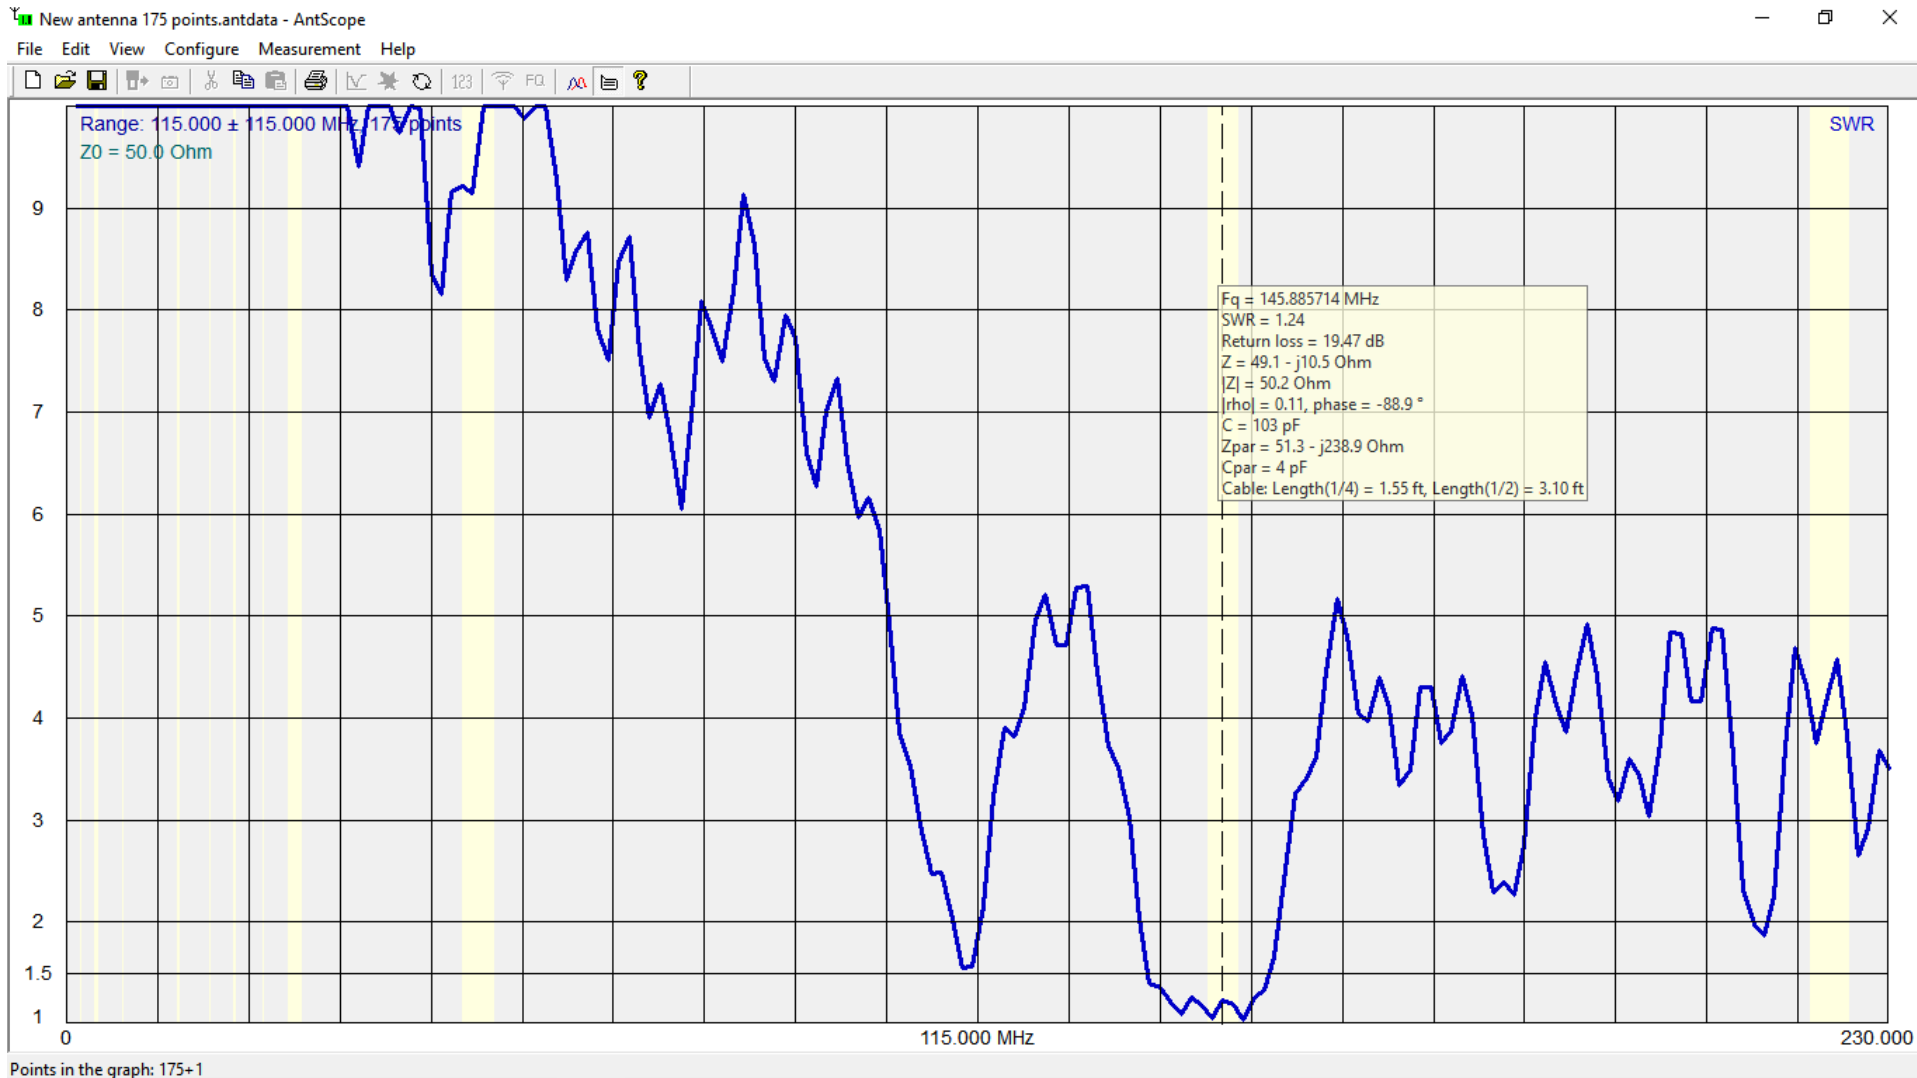
This is the SWR plot for the antenna tested on the previous screen. Not a bad SWR in the VHF range. The antenna checks out fine. Notice the plot line is thin since it is not being tested in a high RF environment.

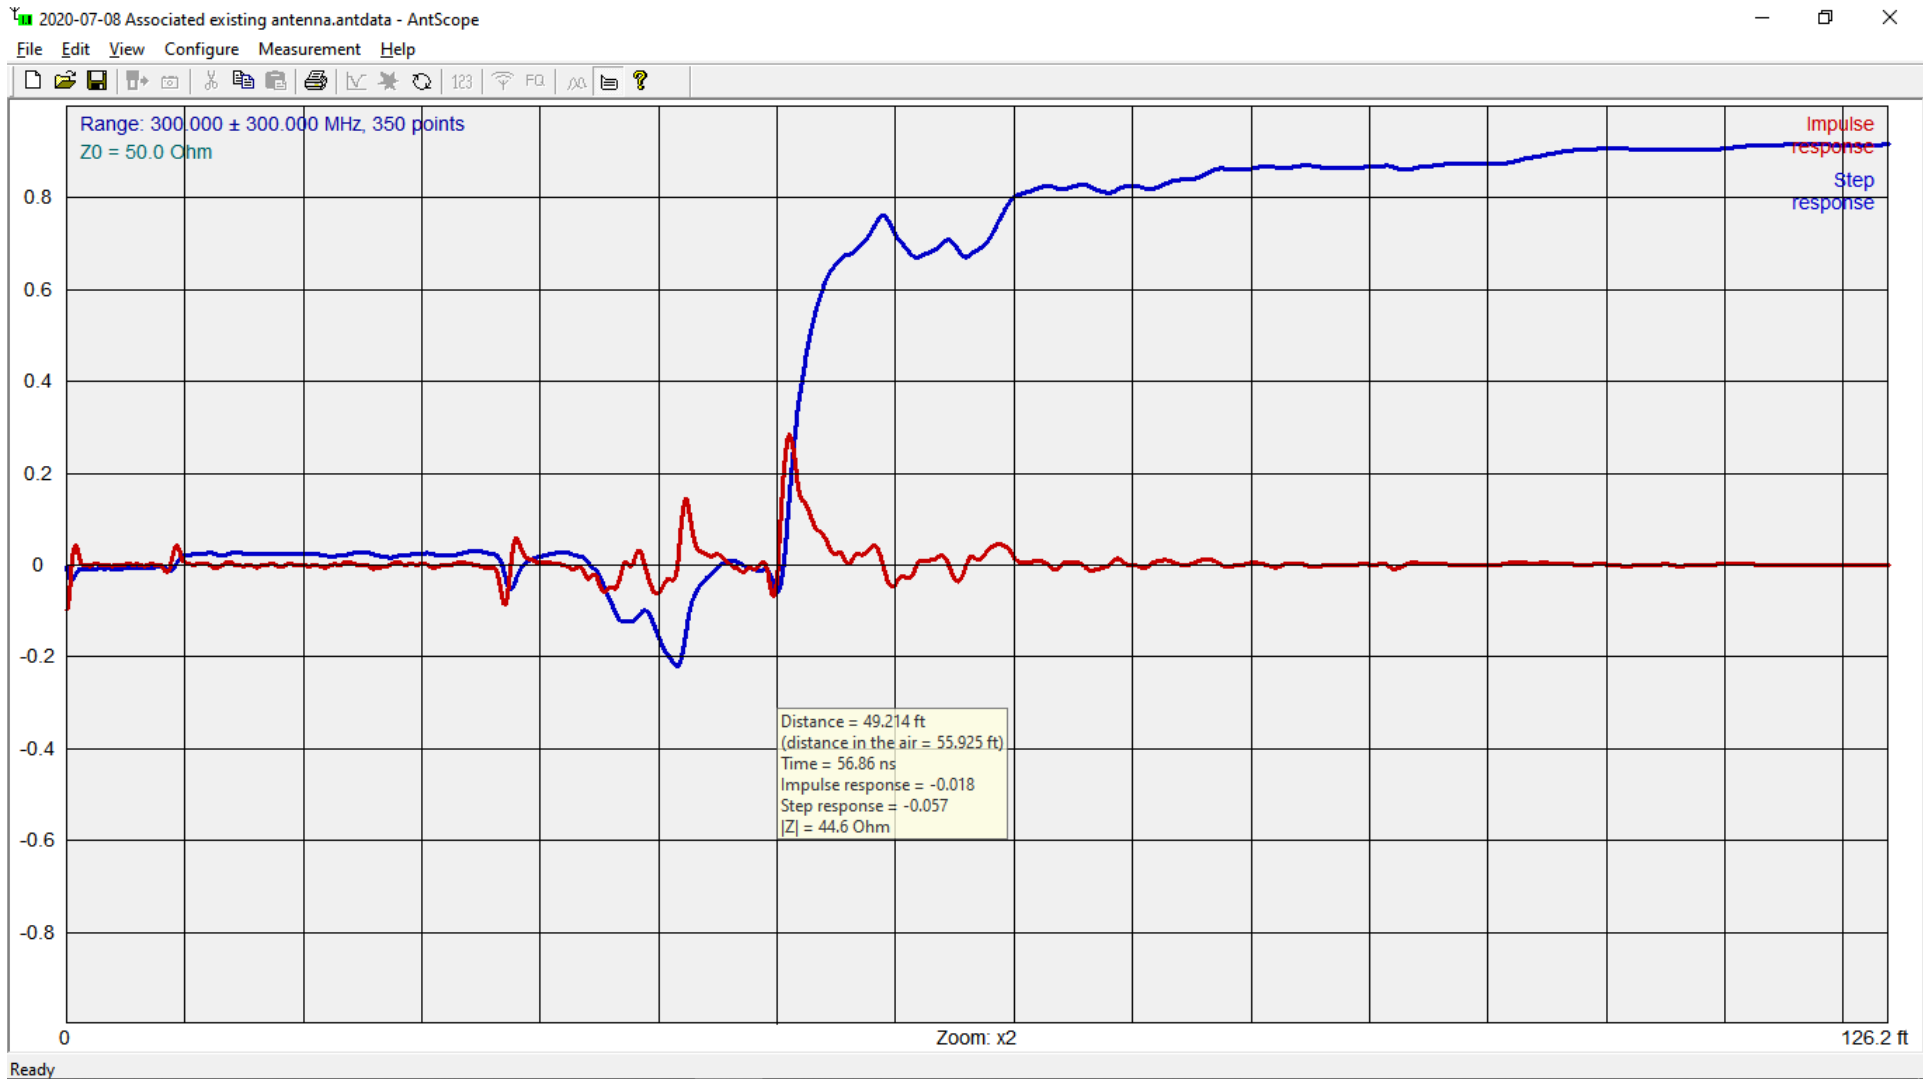
This is a relatively short feedline to a dual band antenna. We believe this to be a good indication of water that has seeped into the coax.

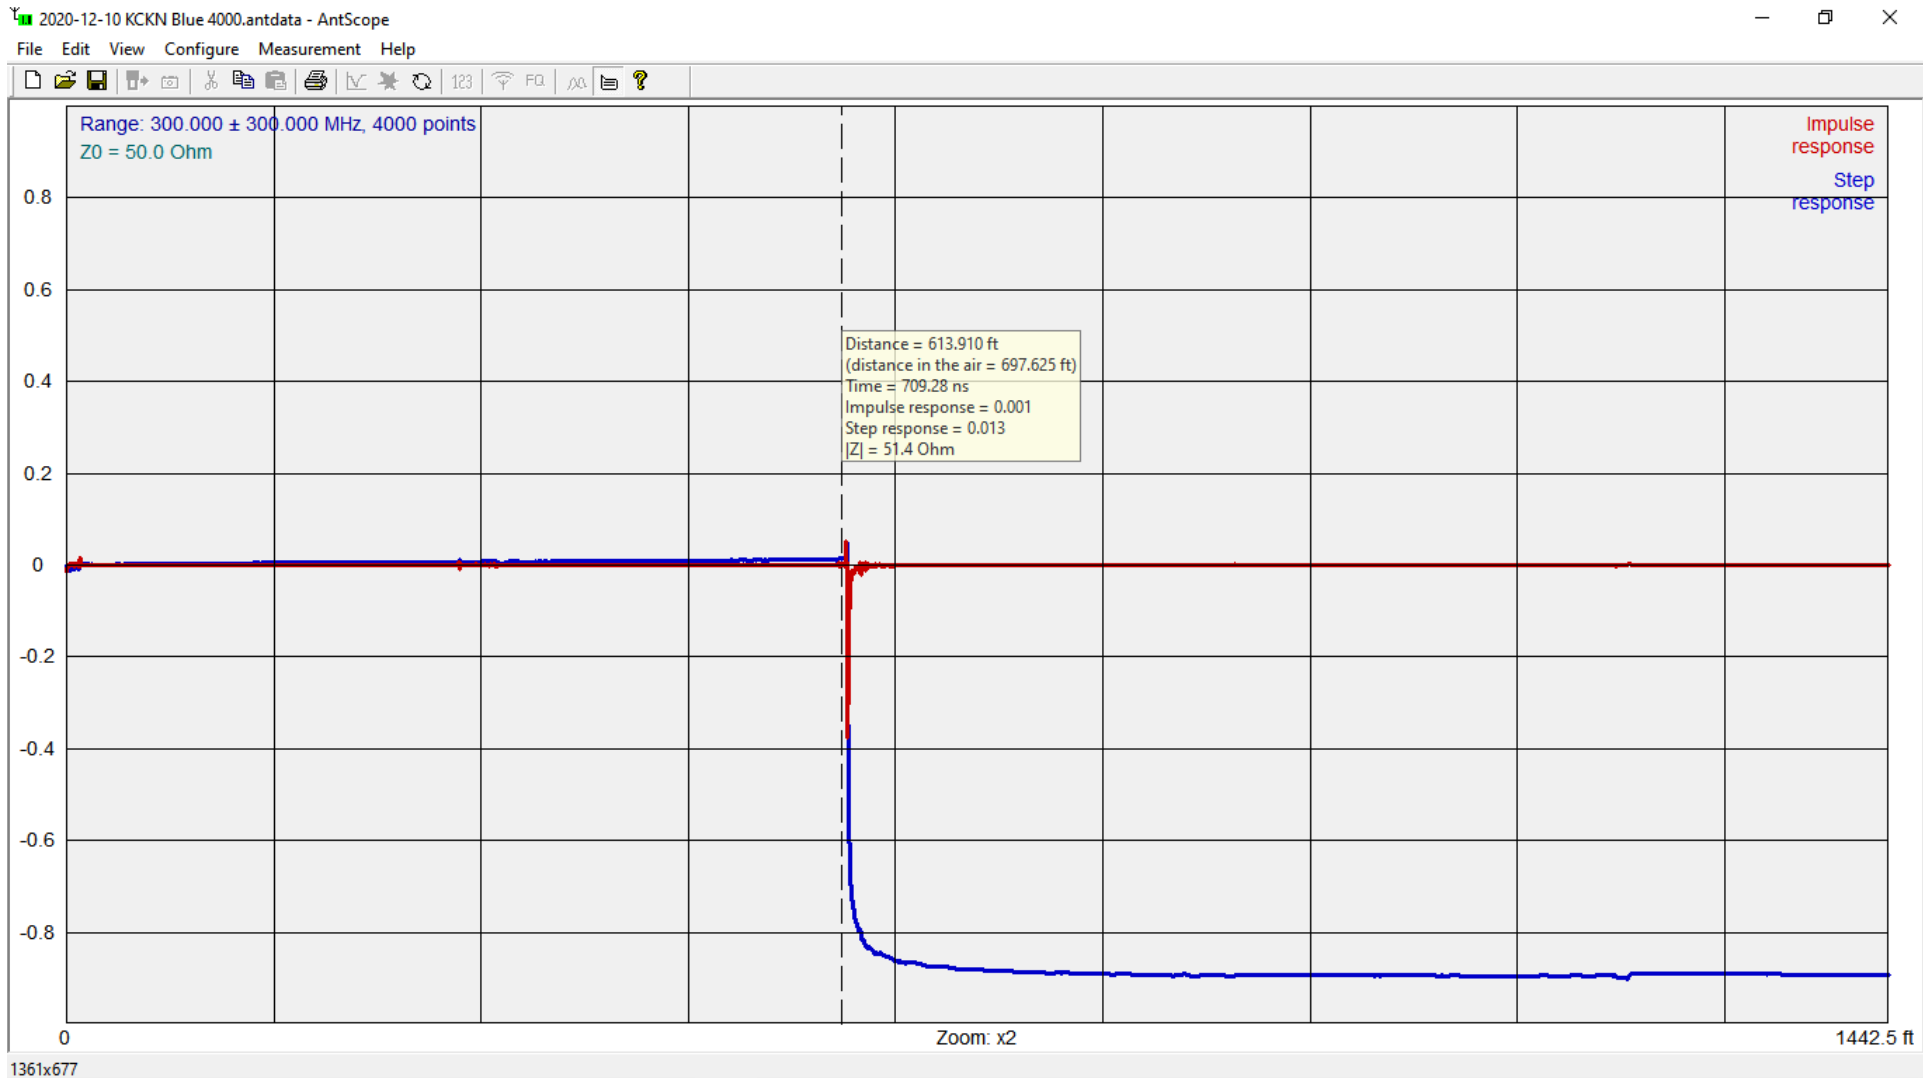
This is a 600 foot run to a grounded UHF “stick” type of antenna. It has a few minor issues but none of which would prevent using this antenna.

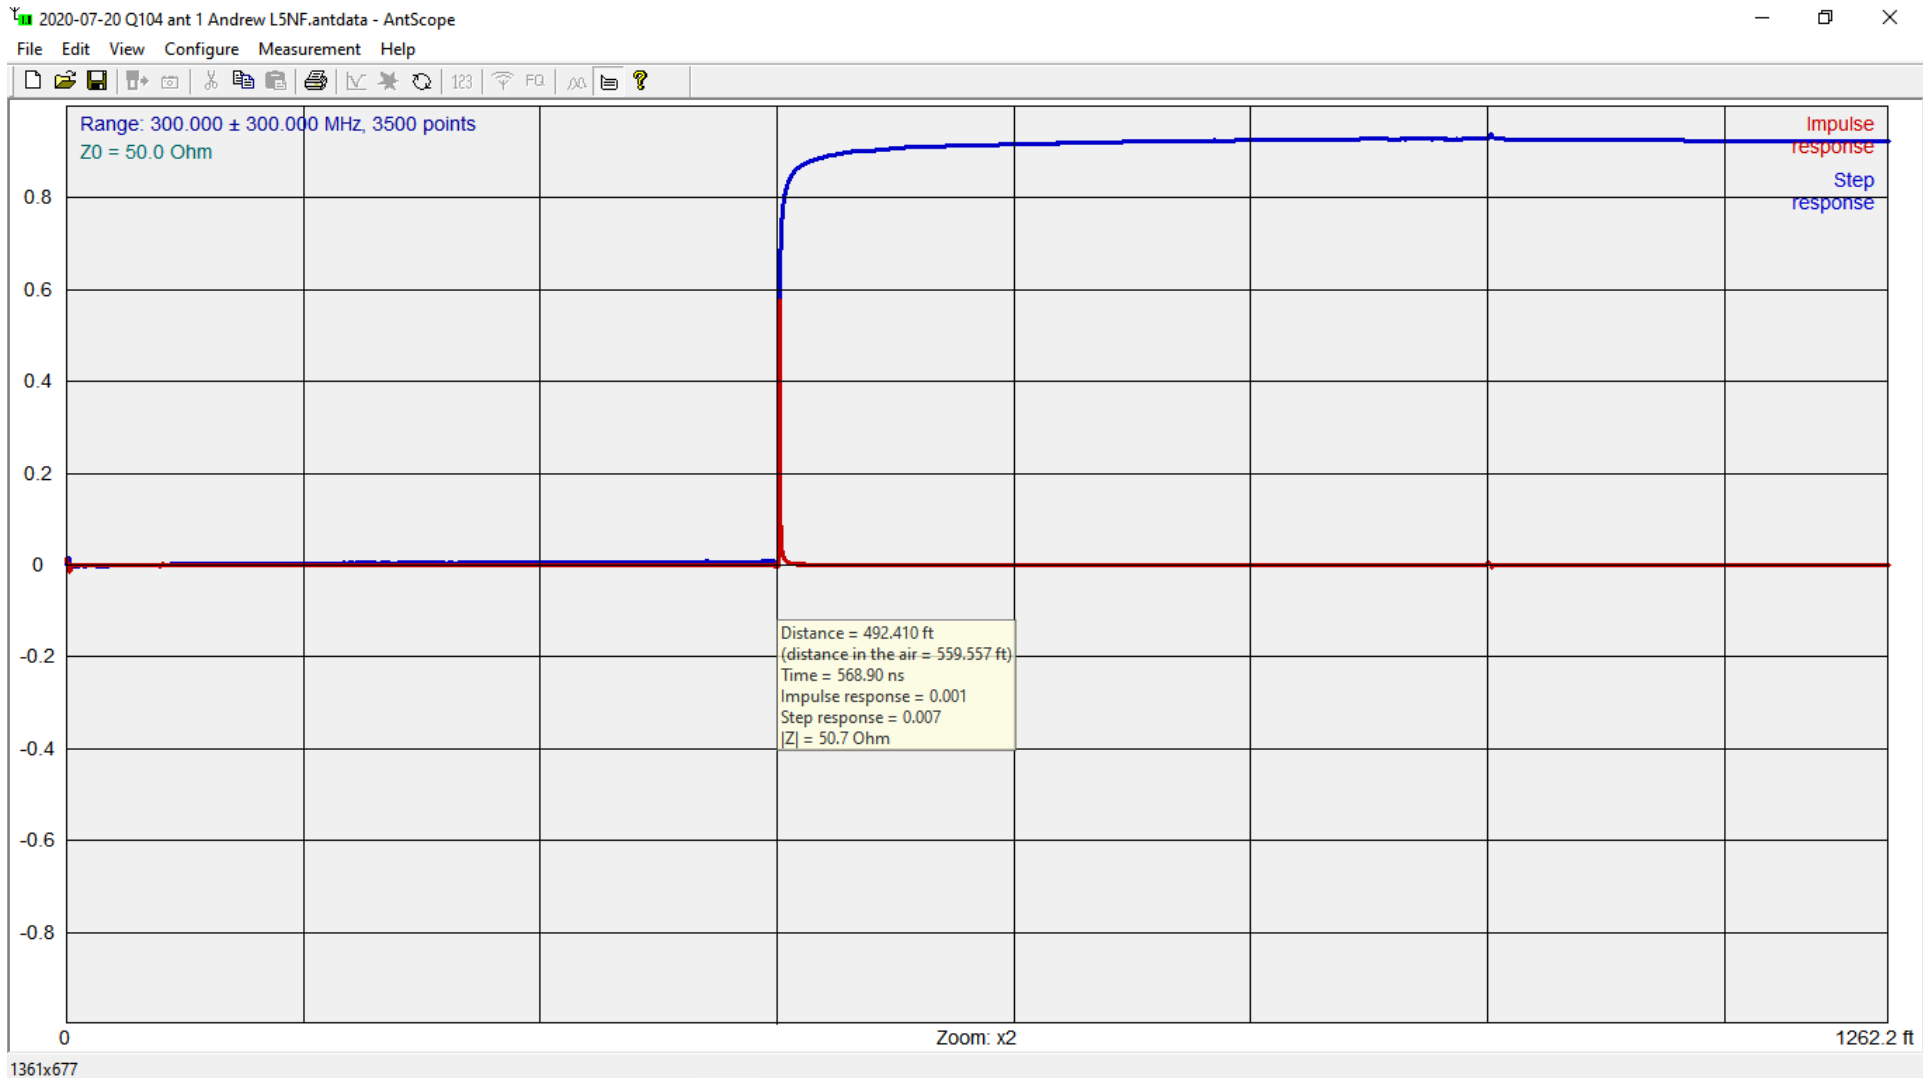
This is a 500 foot run to an ungrounded UHF “stick” type antenna. There are no problems using this antenna.

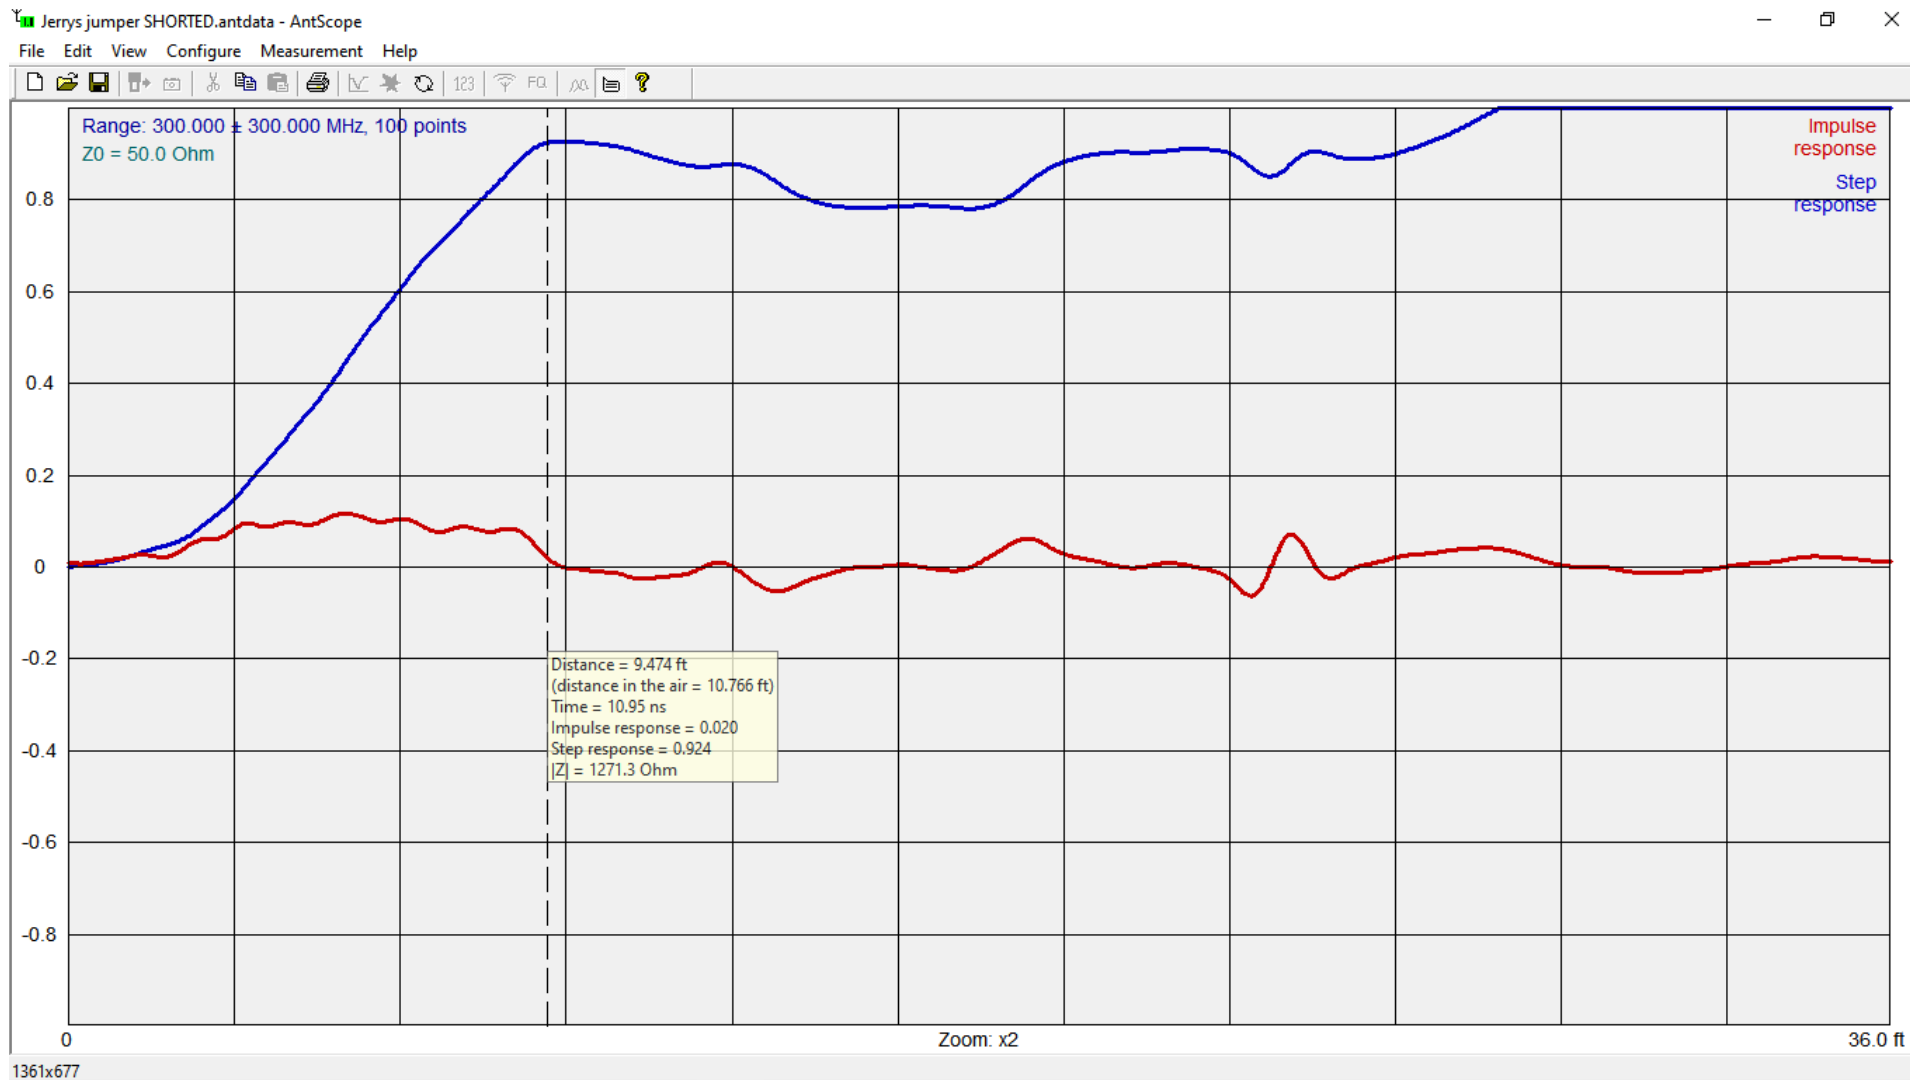
This is a 17.5 foot jumper we tried using from the Rig Expert AA-600 to the connector on the antenna feedline. The resulting scan produced a graph so unusual I decided to check the jumper. This is the scan of that jumper with the far end shorted. As you can see the cable is totally unusable. Upon further examination the braid of the cable appeared to have deteriorated to the point it did not pass a continuity test from one end to the other. There was no water egress into the cable and no determination was made as to why it failed the continuity test. This cable was cut up and discarded.
