Time Domain Reflectometer Analysis of Coaxial Feedlines for Various Repeaters in The Kansas City Room

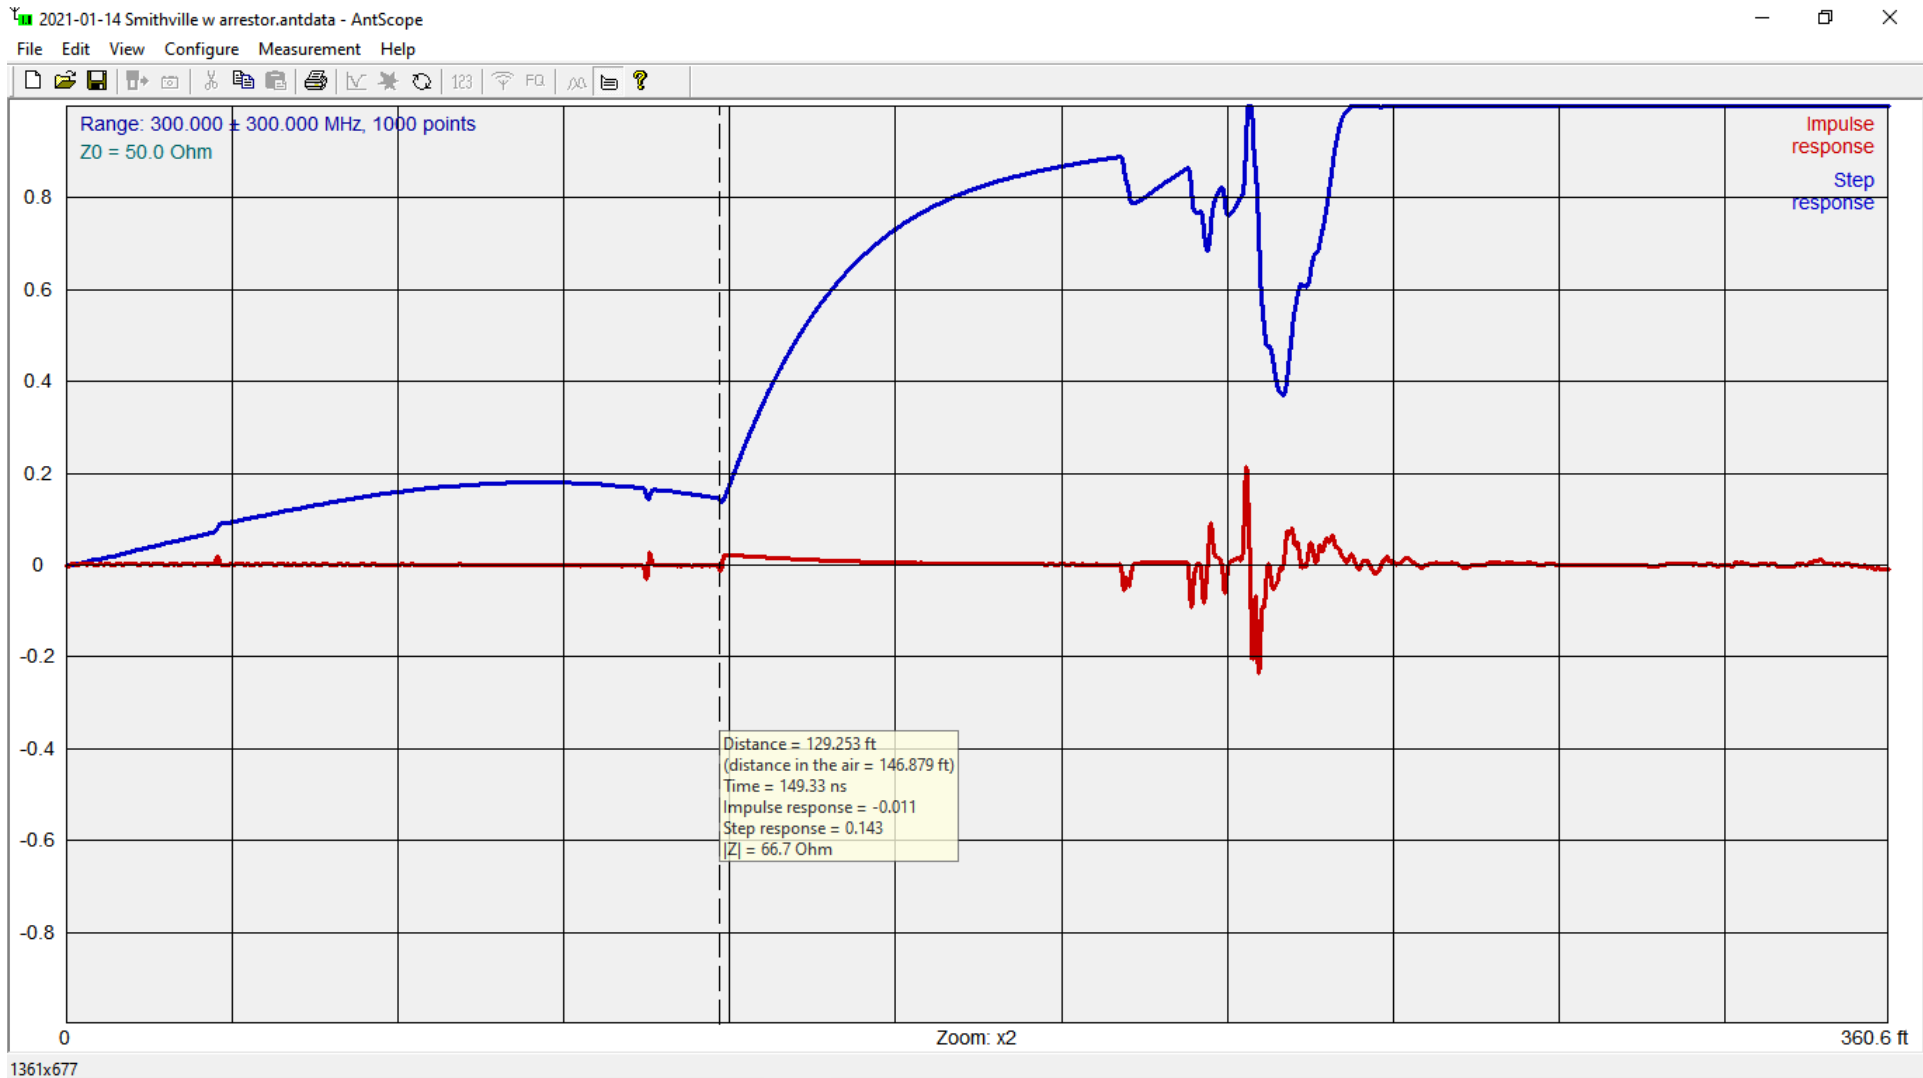
This is our latest installation. It is a DB-224 antenna mounted at 80 feet. Based on previous experience, we determined that there was a lightning arrester in the line. We found a Polyphaser lightning arrester at the cable entrance to the building. We replaced it with a bullet (or barrel) connector and reran the scan. It is on the next page.

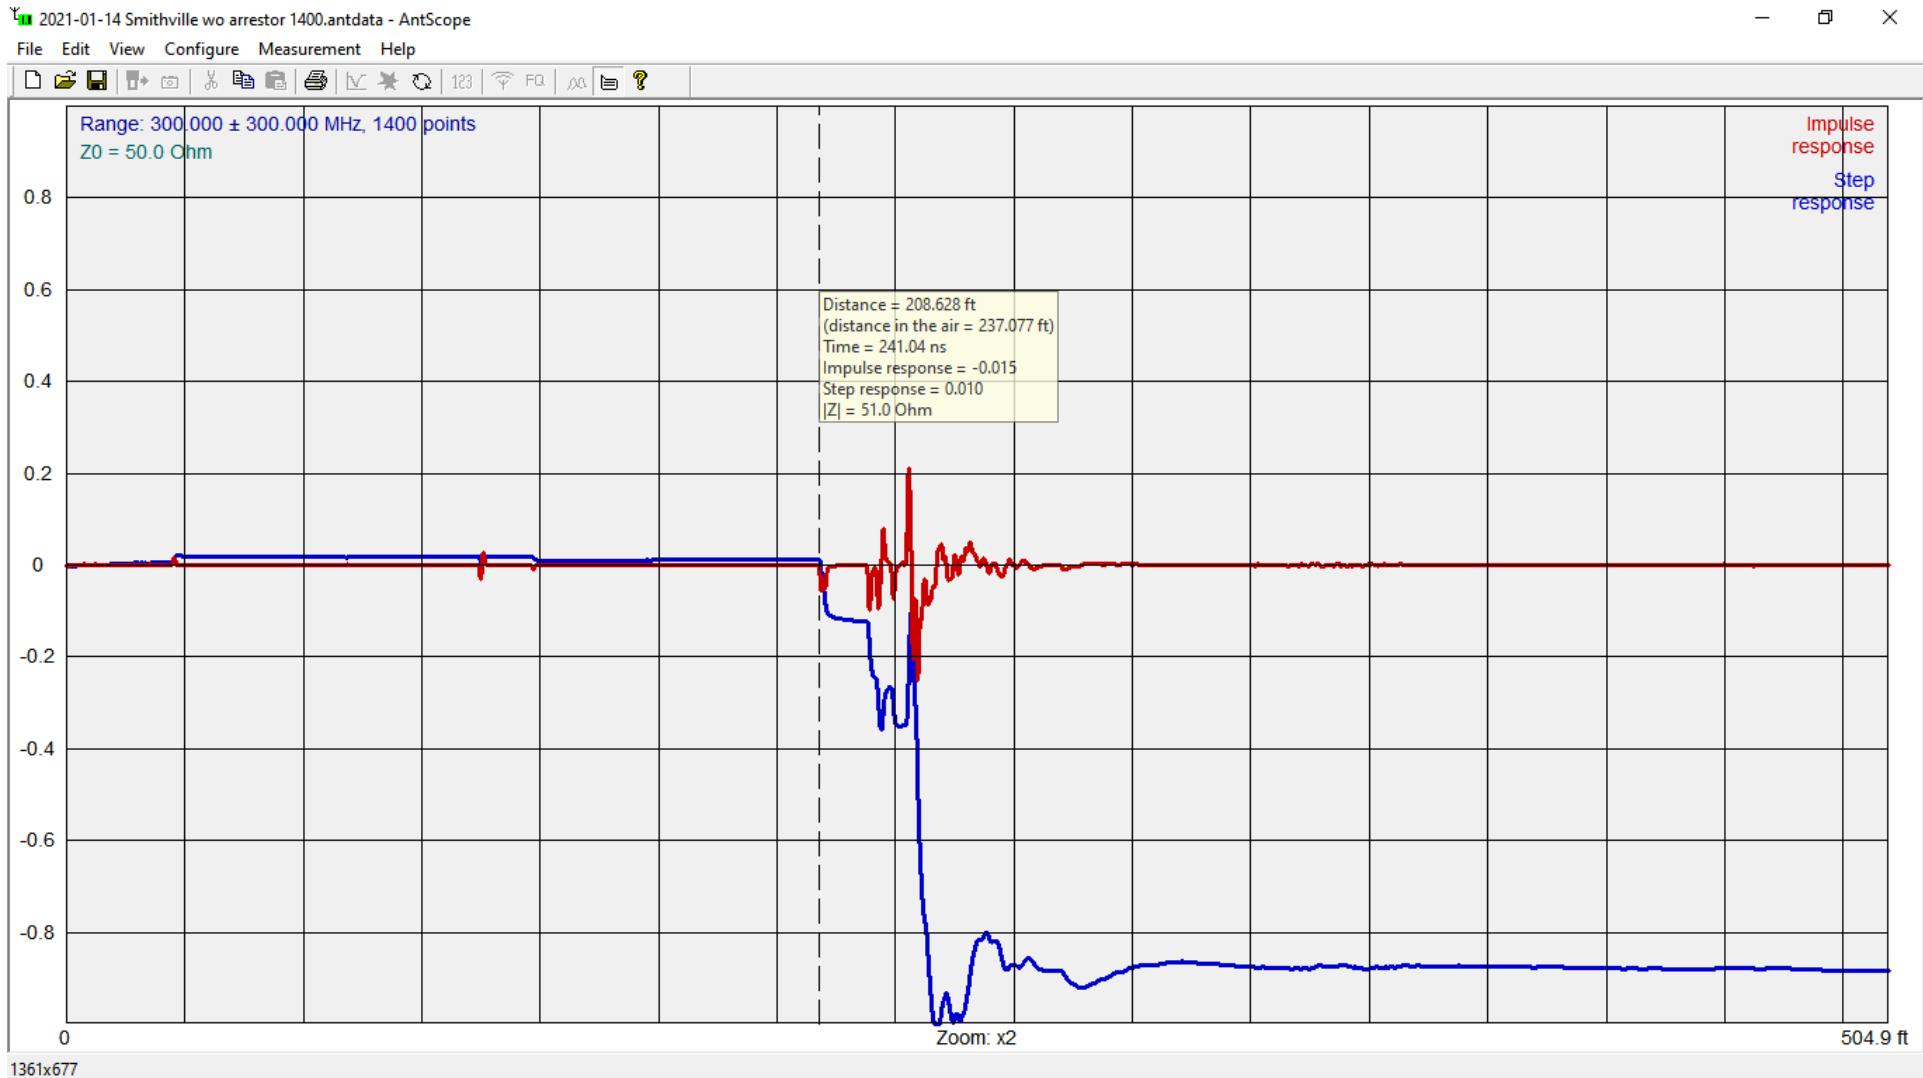
This is the feedline without the arrestor. You can see several blips in the red line indicating connections from one piece of feedline to another. The large red blip in the fourth square from the left could be a kink or a compression of the feedline at that point. Without visual inspection there is no way to tell the exact cause. This is a DB-224 commercial antenna being used in the VHF ham band. The blue line signature is indicative of an out of phase condition caused by using the antenna at a frequency it was not constructed for. The antenna will still function and has a relatively low SWR but the radiation pattern will be adversely affected by the out of phase condition. We inserted a different brand of lightning arrestor and ran the scan again. It is on the next page.

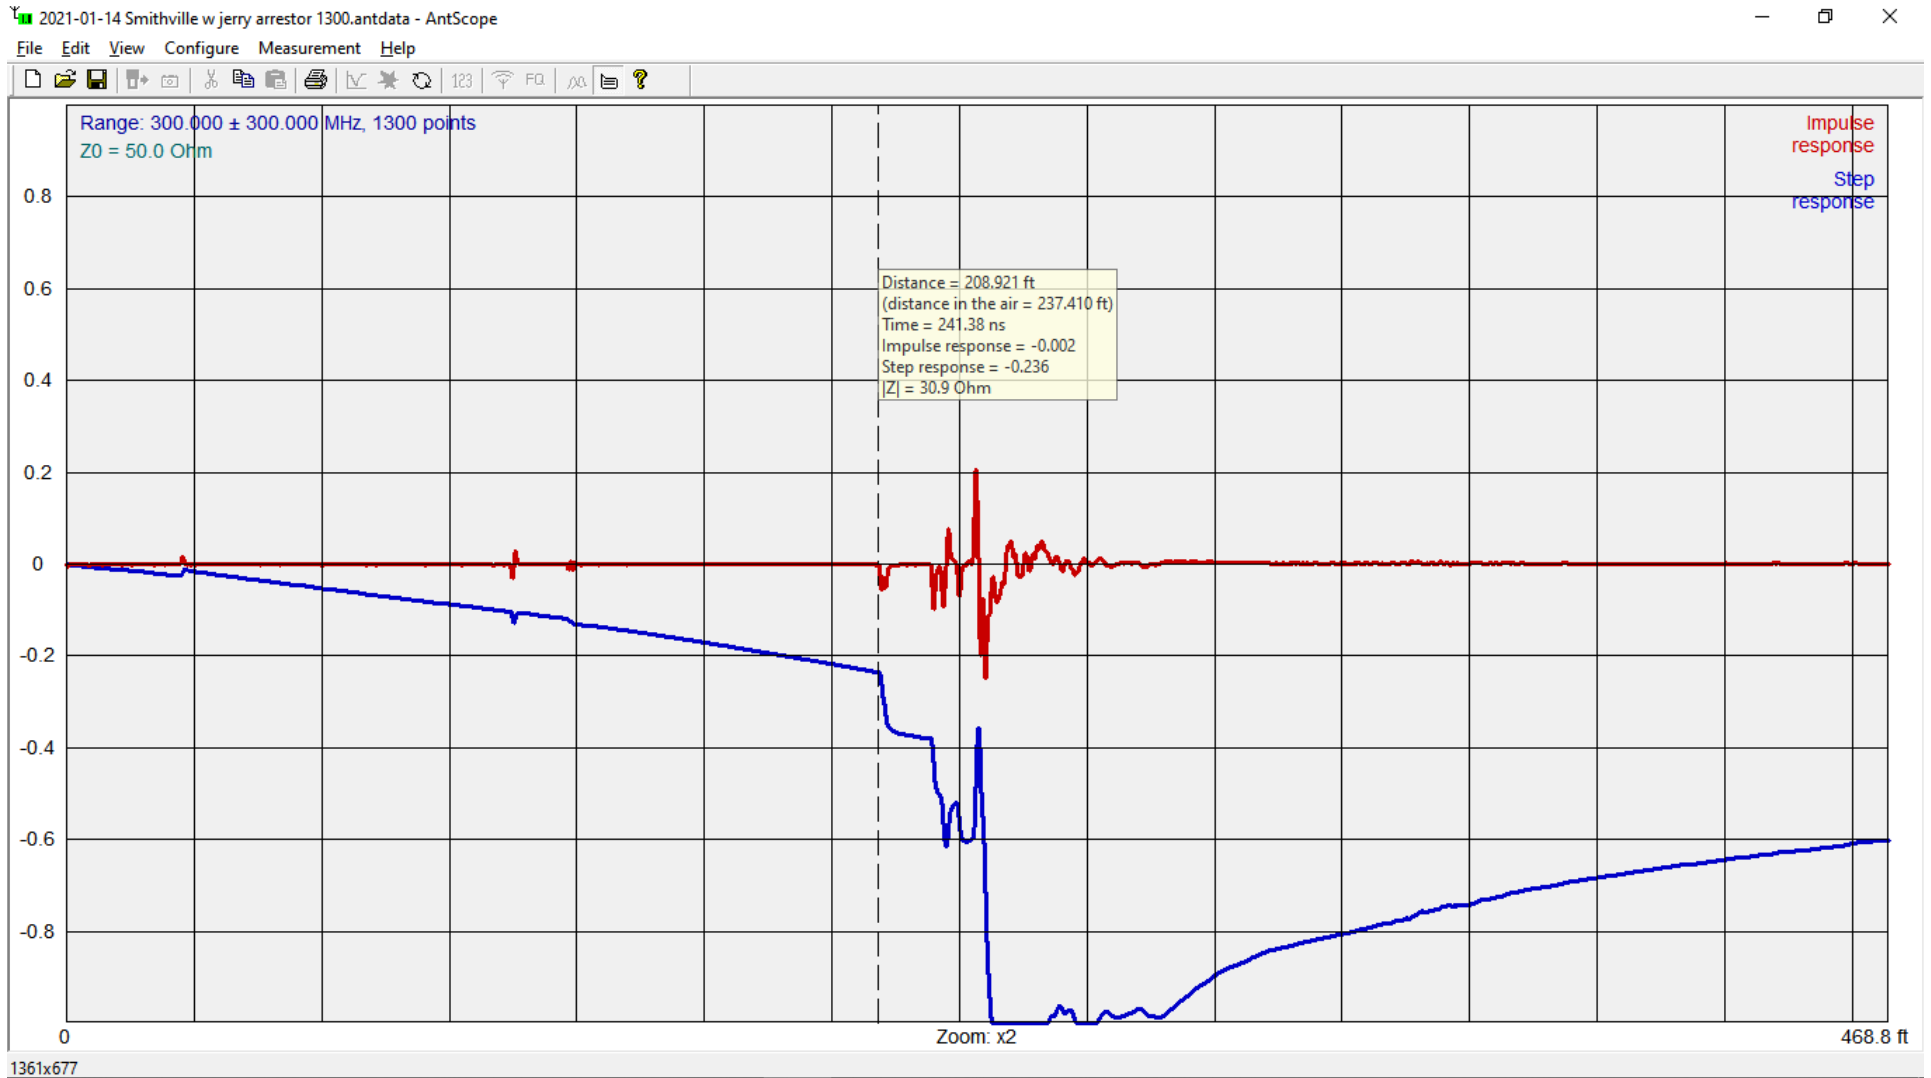
This is the same feedline but the bullet has been replaced by an Array Solutions lightning arrester. You can see how the scan result is affected by a different brand of arrester. This shows us that we can tell what type of arrester is in the feedline by the signature on the scan.
