Time Domain Reflectometer Analysis of Coaxial Feedlines for Various Repeaters in The Kansas City Room

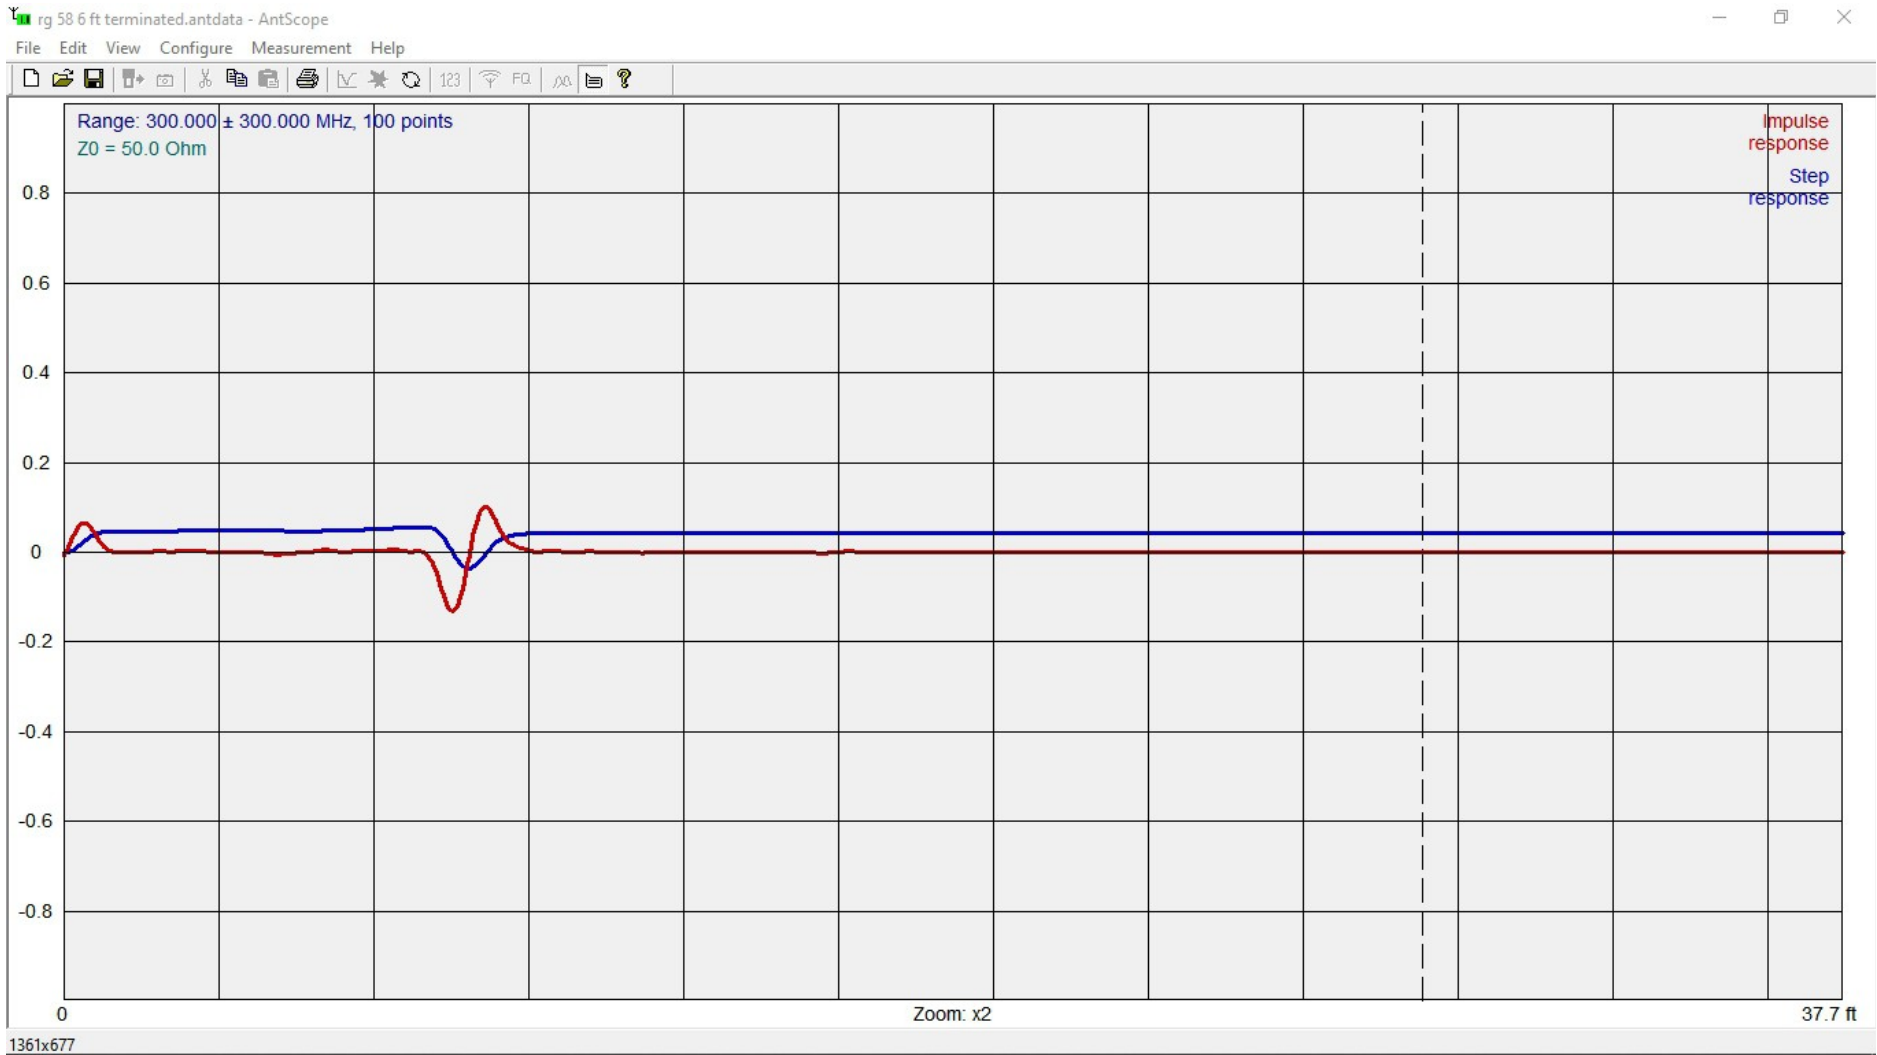
This graph represents a 6 foot piece of RG-58 coax terminated into a 50 ohm load. Notice the number of points is 100 and the total length represented on the graph is 37.7 feet. It is imperative that the number of points allows the graph to represent at least twice the length of the cable under test which in this case would be 12 feet. I would have used less than 100 points but that is the minimum allowed by the AA-600.

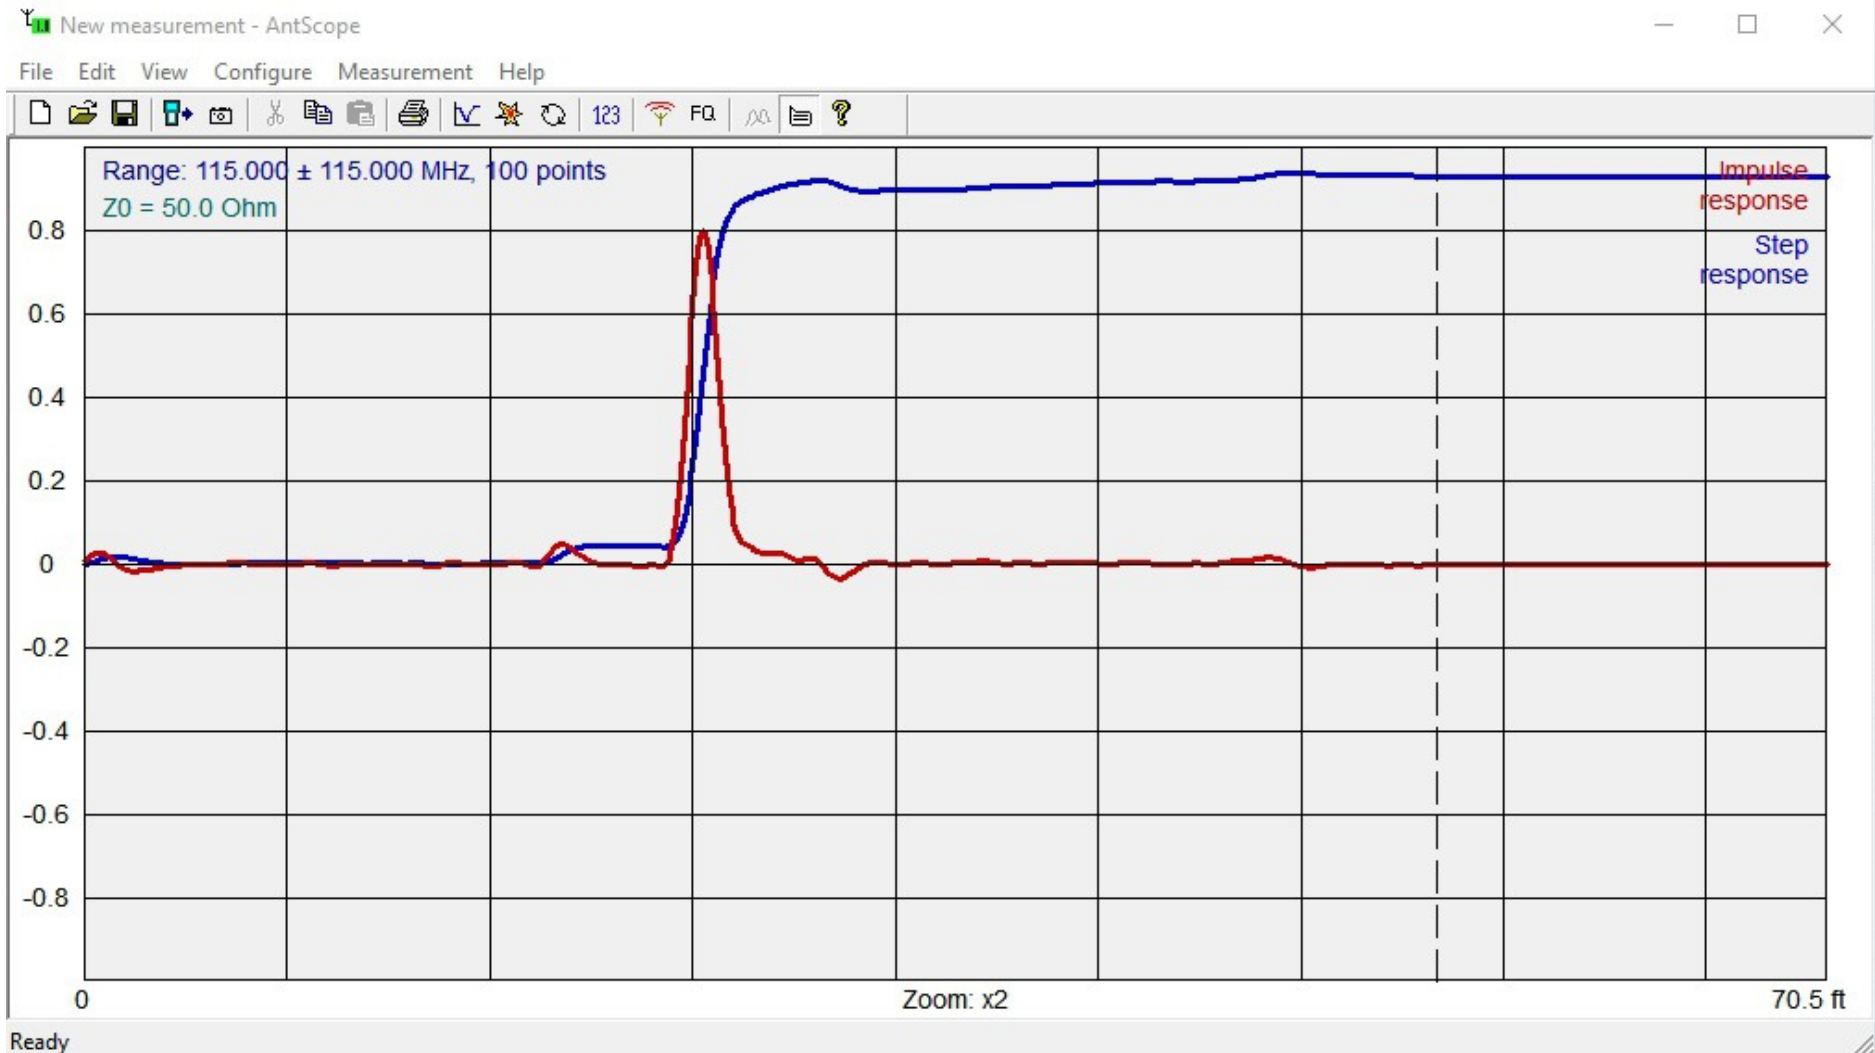
This is the same 6 foot piece of RG-58 coax but the end is open. You can see how the step response trace (blue line) turns upward at the end of the cable. This is also indicative of a capacitive connection. This scan and the one on the next page were done using a Rig Expert AA-230 Zoom. It's minimum number of points is also 100 but you can see that 100 points represents 70.5 feet instead of 37.7 as on the AA-600.

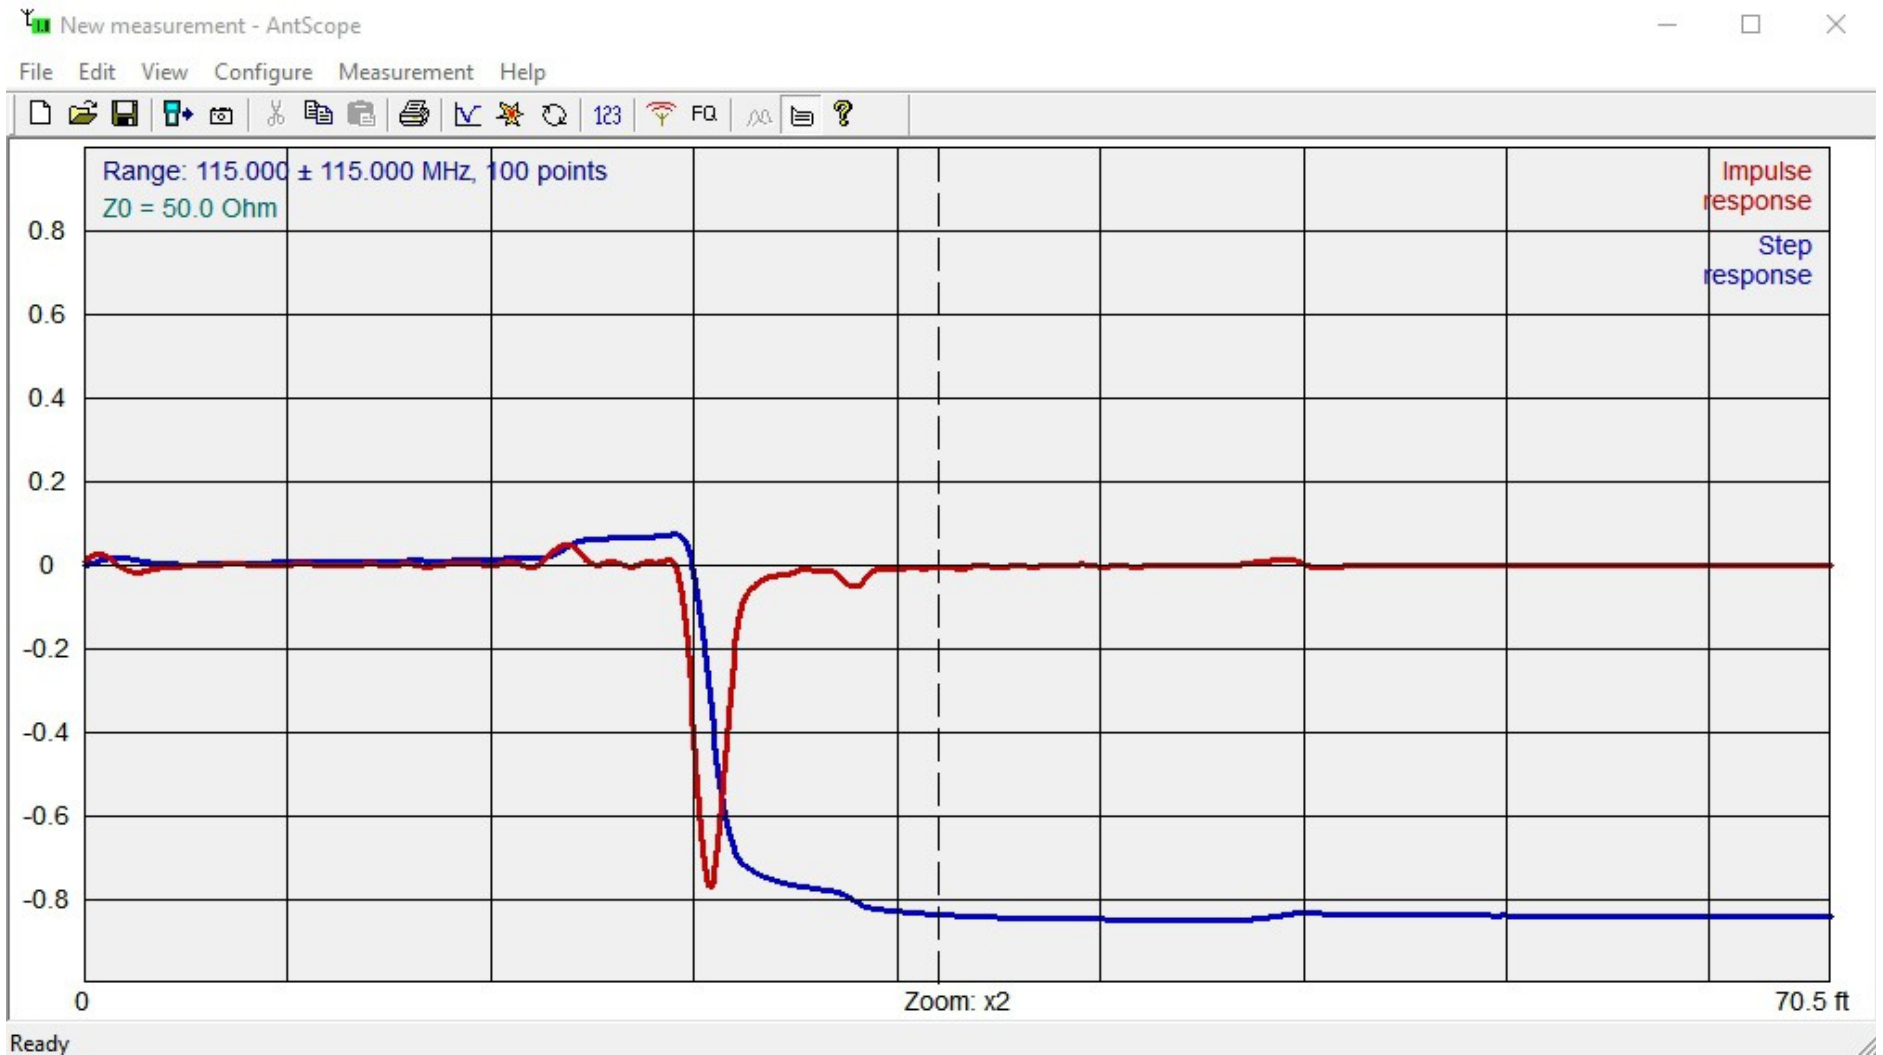
This is still the same 6 foot piece of RG-58 coax but the end is now shorted. You can see how the step response trace (blue line) turns down at the end of the cable. This is indicative of an inductive connection.
